**AT&T:**  
Abandoning Rural & Other  
Communities in Indiana

## AT&T Copper Plant Photos – Indiana

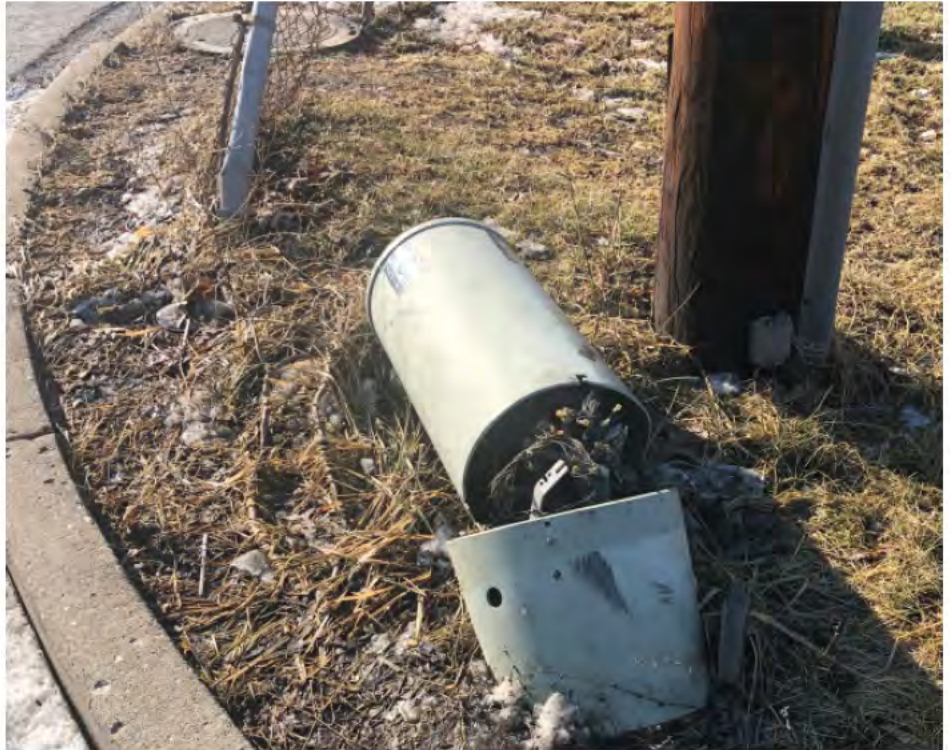
1. This photo from West 25th Street, Anderson, IN, shows a damaged pedestal on its side next to a public street. Wires are exposed to damage from weather and animals. Damaged wires cause service outages. In addition, the exposed wires are a public safety hazard.

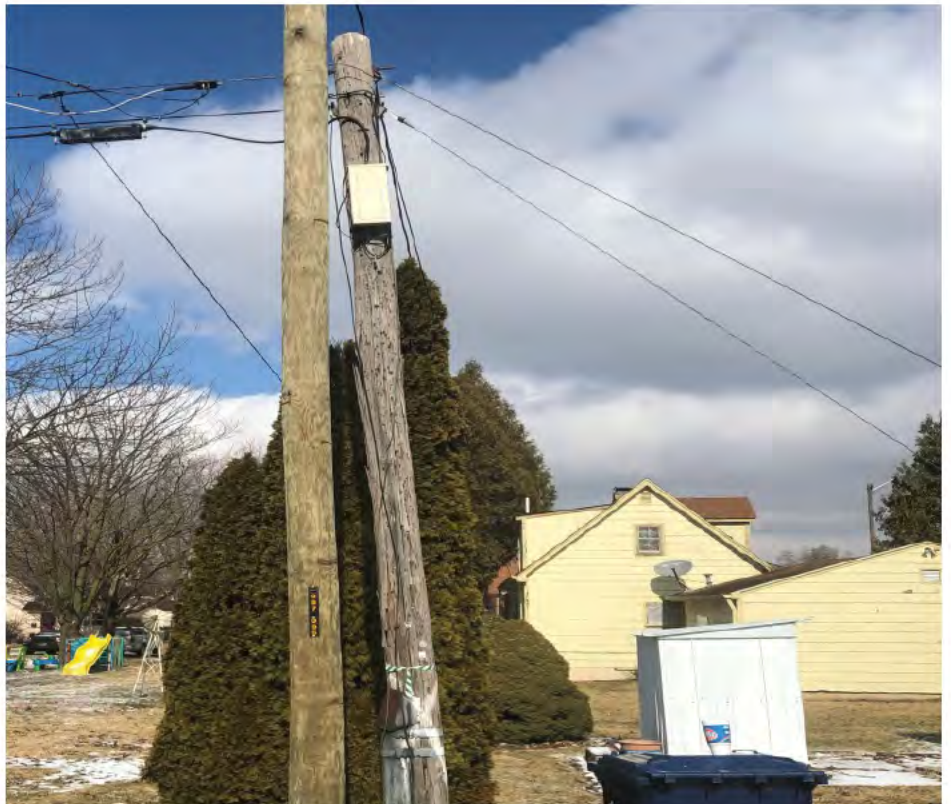
2. This photo from Christian Avenue, Noblesville, IN, shows a double-pole. The old pole (right, with a white spray-painted X) with only AT&T equipment attached to it is tied to the new pole with rope to prevent it from falling. AT&T has not moved its facilities to the new utility pole. As a result, AT&T's equipment remains connected to old, deteriorating poles, causing potential service and safety concerns.

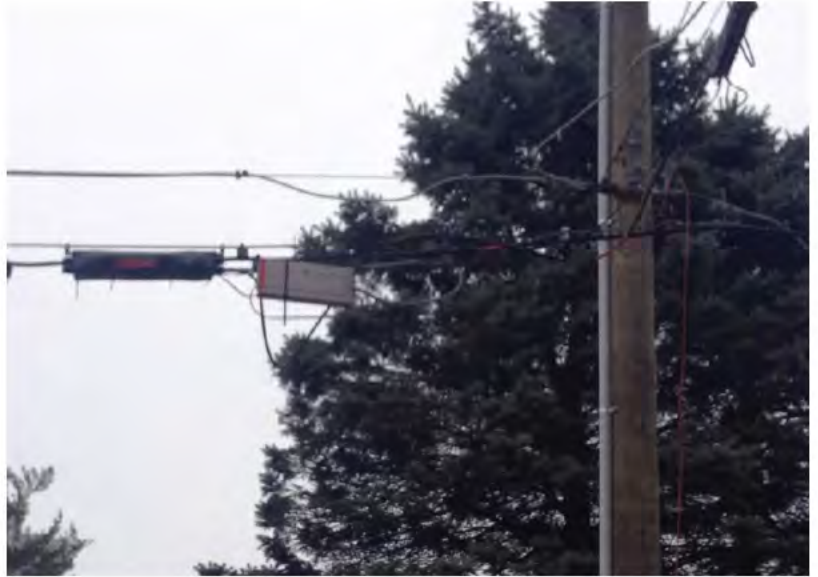
3. This photo from M Street, Bedford, IN, shows an unsecured terminal. The terminal should be secured to the pole, not tied to the cable. The terminal can fill with water, deteriorating wires and leading to service issues. In addition, the terminal is wrapped shut with electrical tape, which is not designed to keep a terminal closed. This presents a serious public safety hazard.

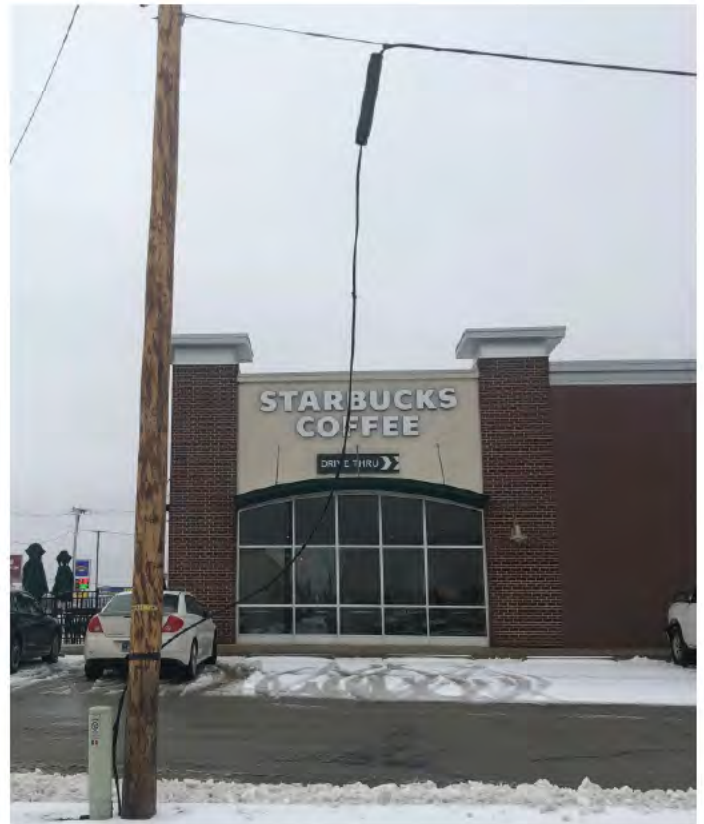
4. This photo from West 32nd Street, Marion, IN, shows unsecured cables. The cables should be secured to the utility pole. The wind blows the unsecured service cables, damaging the copper inside the wire and causing service issues. In addition, these cables are within reach of passersby, causing a public safety hazard.

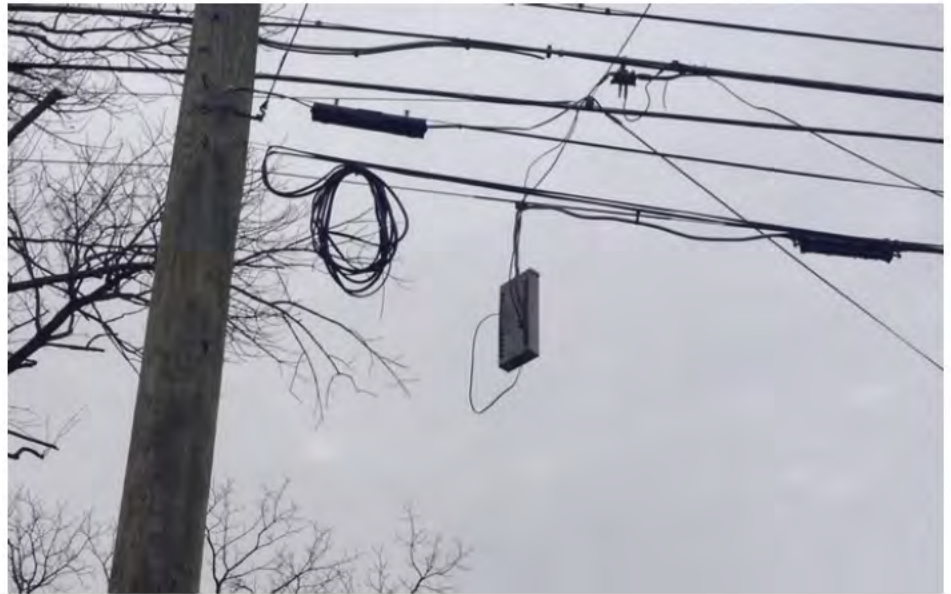
5. This photo from Lincoln Avenue, Bedford, IN, shows an unsecured terminal hanging from service wires. The terminal should be secured to the pole. The terminal can fill with water, deteriorating wires and leading to service issues. A hanging terminal presents a public safety hazard.

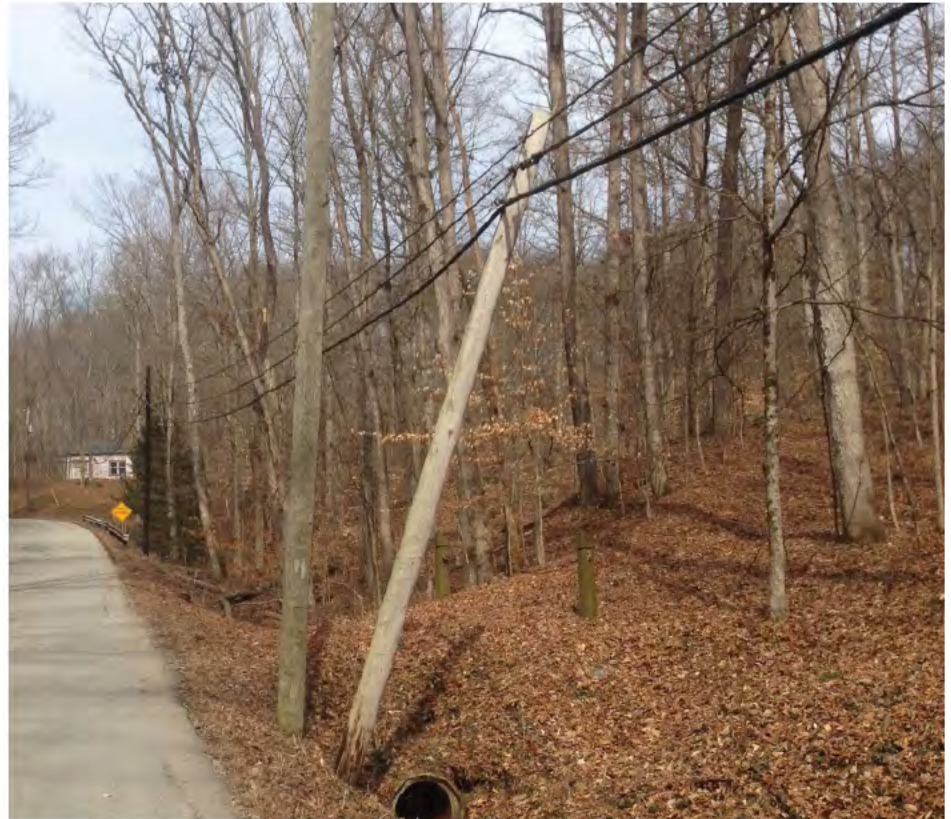
6. This photo from Helmsburg Road, Nashville, IN, shows a double-pole. The old pole (right) is significantly damaged and leaning, putting strain on AT&T's cables and equipment, which remain attached. Despite the state of this utility pole, AT&T has not moved its facilities to the new pole. As a result, AT&T's equipment remains connected to an old, damaged pole, causing potential service and safety concerns.

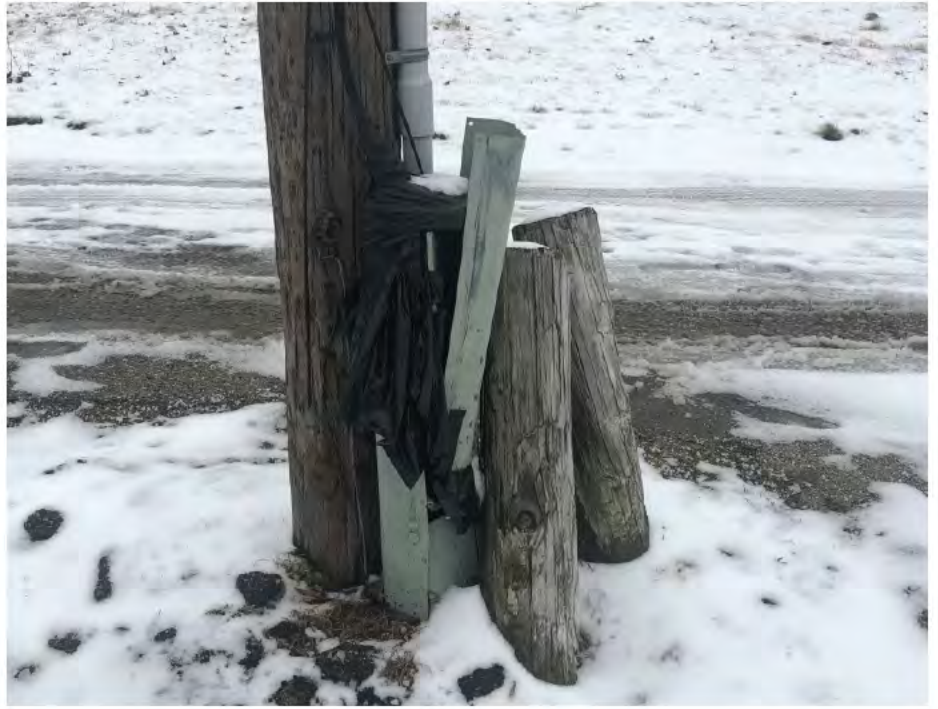
7. This photo from West 5th Street, Marion, IN, shows a damaged pedestal. Its protective cover is missing. It is partially covered by a deteriorated black plastic covering. Wires are exposed to damage from weather and animals. Damaged wires cause service outages. In addition, the exposed wires are a public safety hazard.

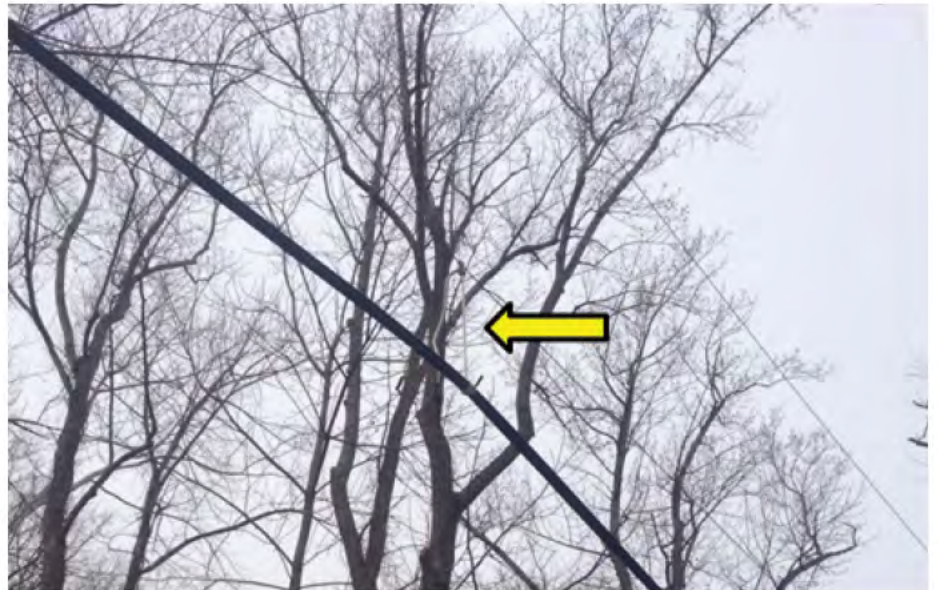
8. This photo from Town Hill Road, Nashville, IN, shows an improperly secured cable. Instead of being properly lashed, this cable is tied to a lash with a piece of rope (yellow arrow). The wind blows the unsecured service cables, damaging the copper inside the wire and causing service issues.

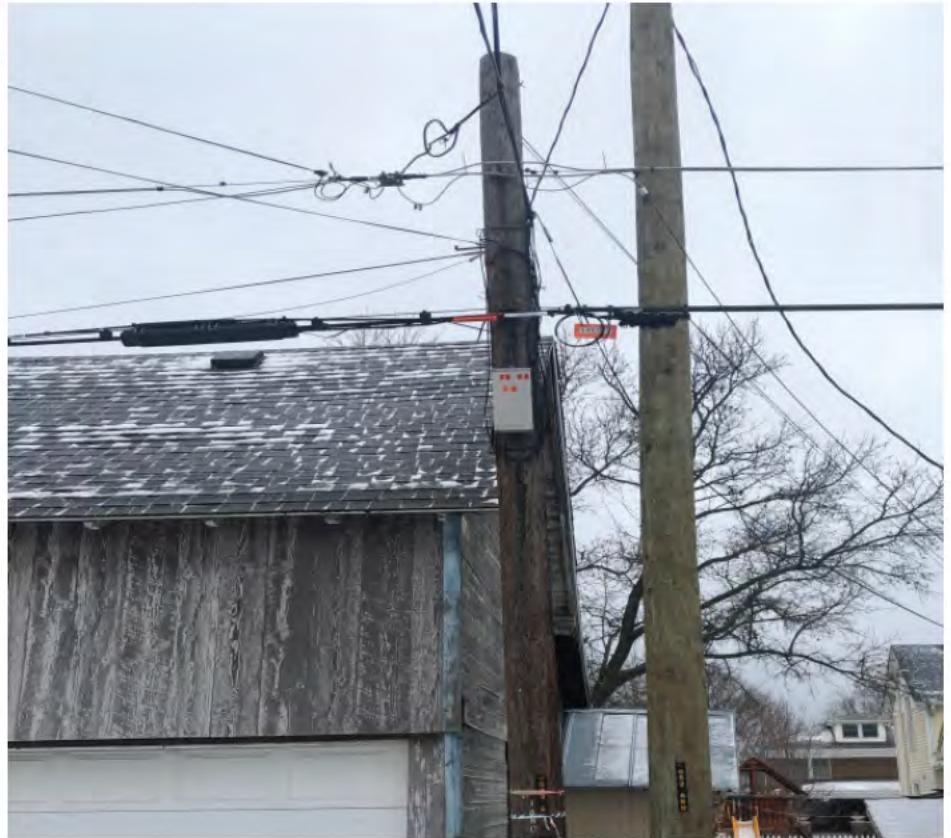
9. This photo from Maple Avenue, Noblesville, IN, shows a double-pole. The old pole (left) has only AT&T equipment attached to it. AT&T has not moved its facilities to the new utility pole. As a result, AT&T's equipment remains connected to an old, deteriorating pole, causing potential service and safety concerns.

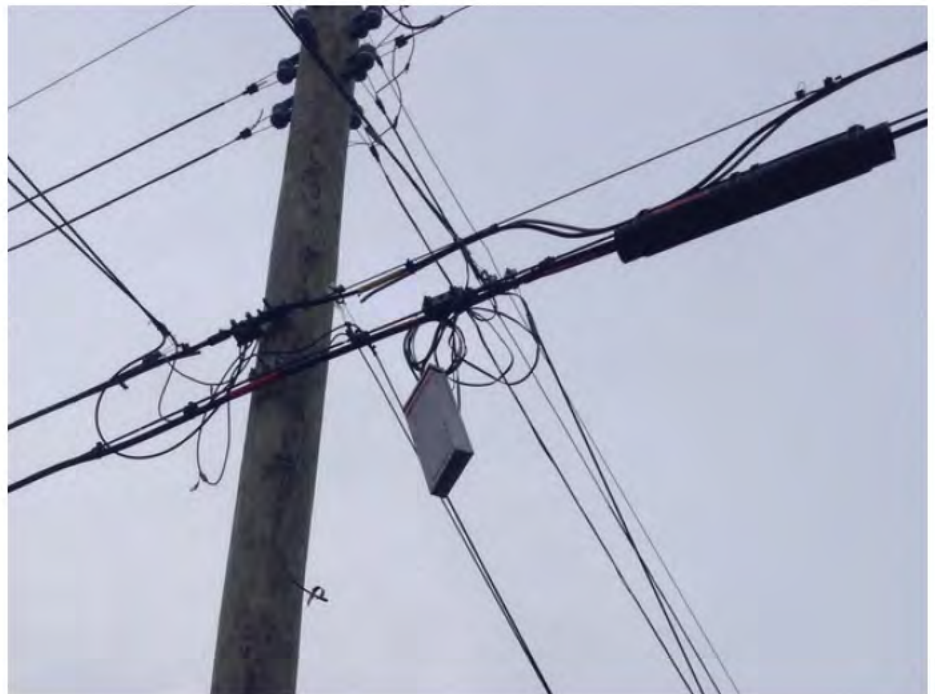
10. This photo from 17th Street, Bedford, IN, shows an unsecured terminal hanging from service wires. The terminal should be secured to the pole. The terminal can fill with water, deteriorating wires and leading to service issues. A hanging terminal presents a public safety hazard.

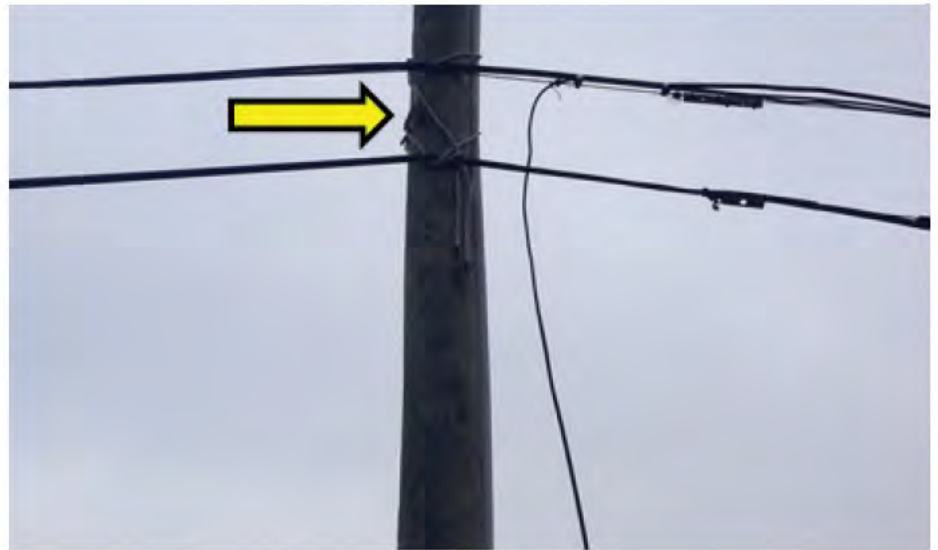
11. This photo from Sandpit Road, Bedford, IN, shows improperly secured cables. The cables are tied to the utility pole with rope (yellow arrow), which will eventually deteriorate, leaving the cables unsecured. The wind blows the unsecured cables, damaging the copper inside the wire and causing service issues.

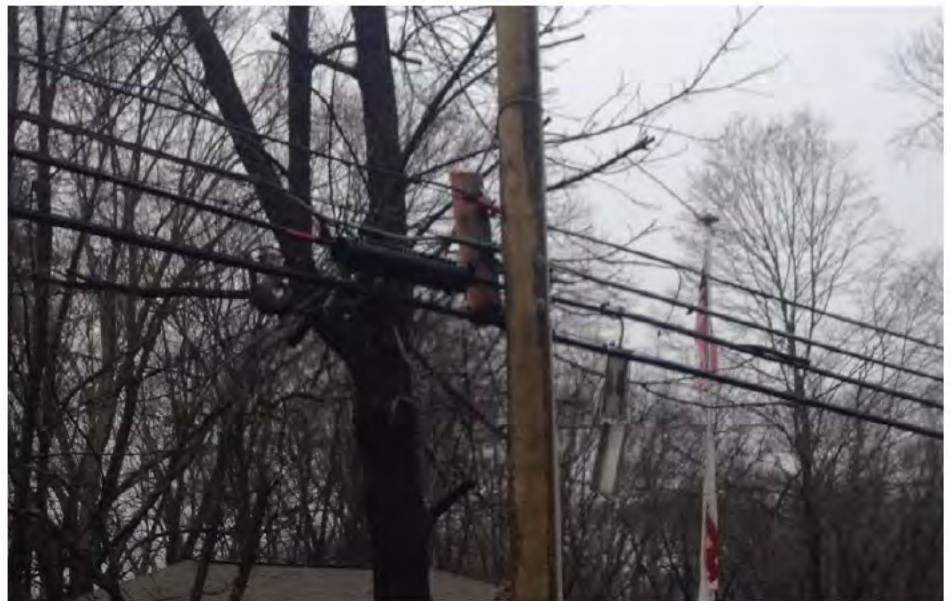
12. This photo from East SR 46, Bloomington, IN, shows a hanging pole, or a double-pole that has been cut before AT&T moved its facilities to the new pole. The old utility pole was cut with AT&T's terminal and cables still attached to it. Left dangling, the old pole strains the cables and endangers the public. It is a service, worker, and public safety concern.

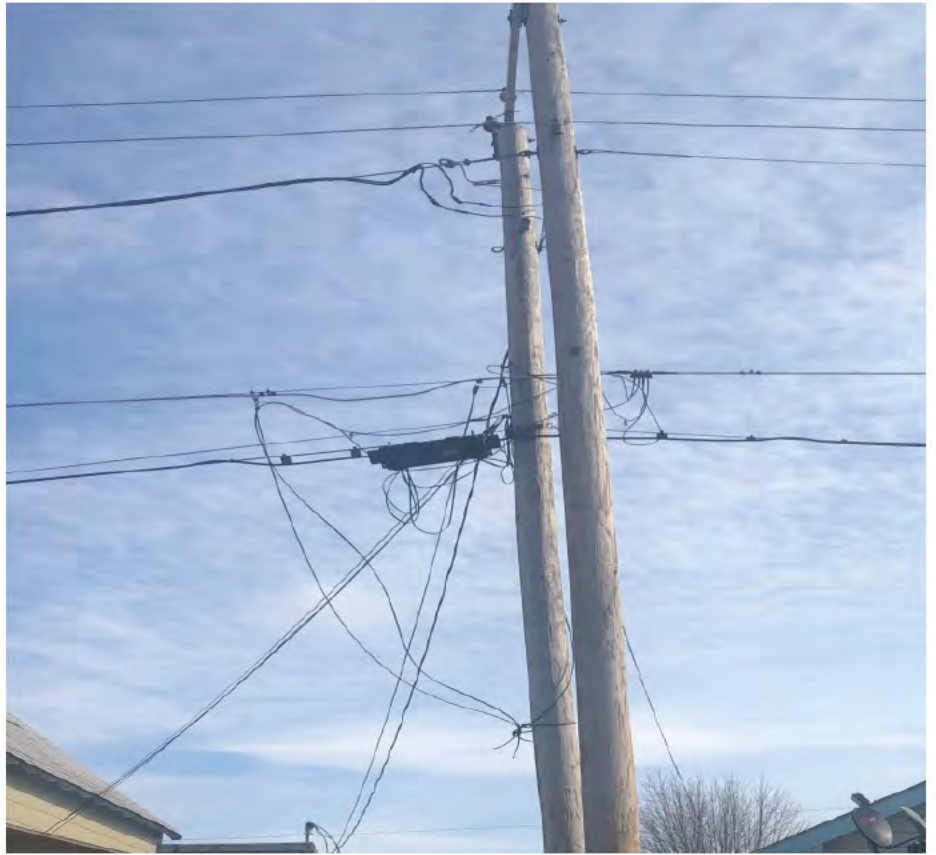
13. This photo from Jefferson Street, Anderson, IN, shows improperly secured wires. The wires are tied around the utility pole. They will eventually deteriorate, leaving the wires unsecured. The wind blows the unsecured wires, damaging the copper inside the wire and causing service issues.

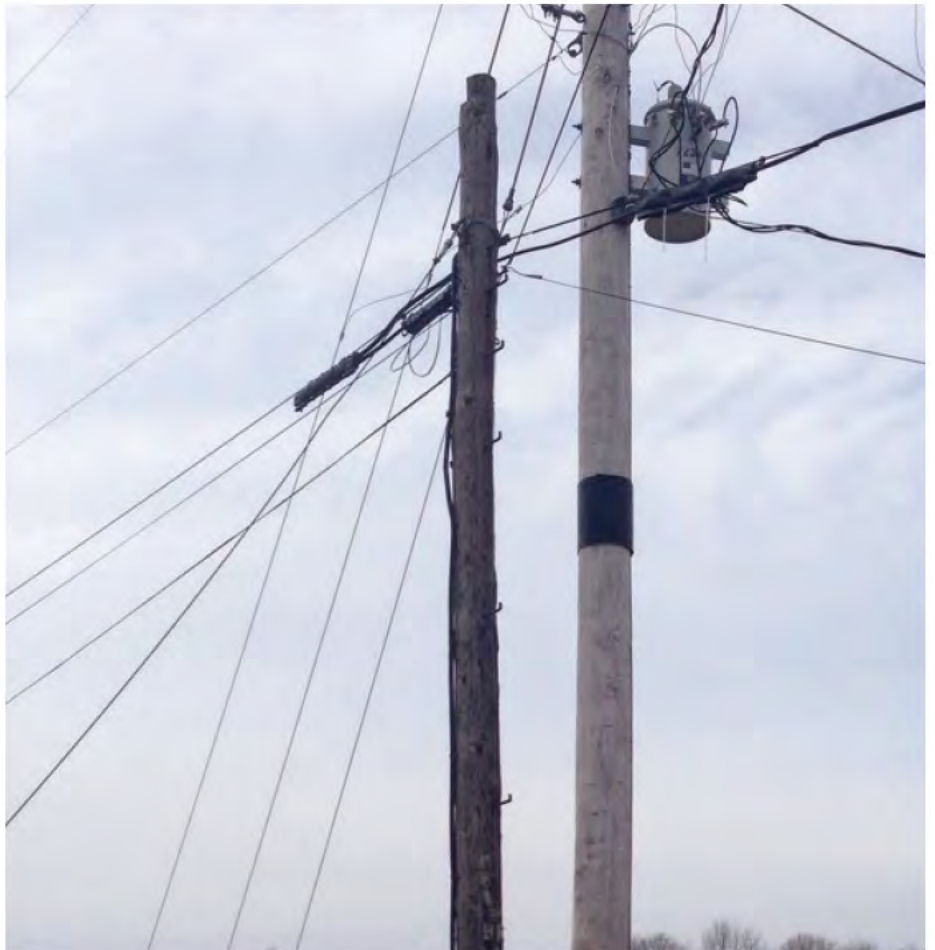
14. This photo from Boone Hollow Road, Bedford, IN, shows a double-pole. The old pole (left) with only AT&T equipment attached to it is tied to the new pole to prevent it from falling. AT&T has not moved its facilities to the new utility pole. As a result, AT&T's equipment remains connected to an old, deteriorating pole, causing potential service and safety concerns.

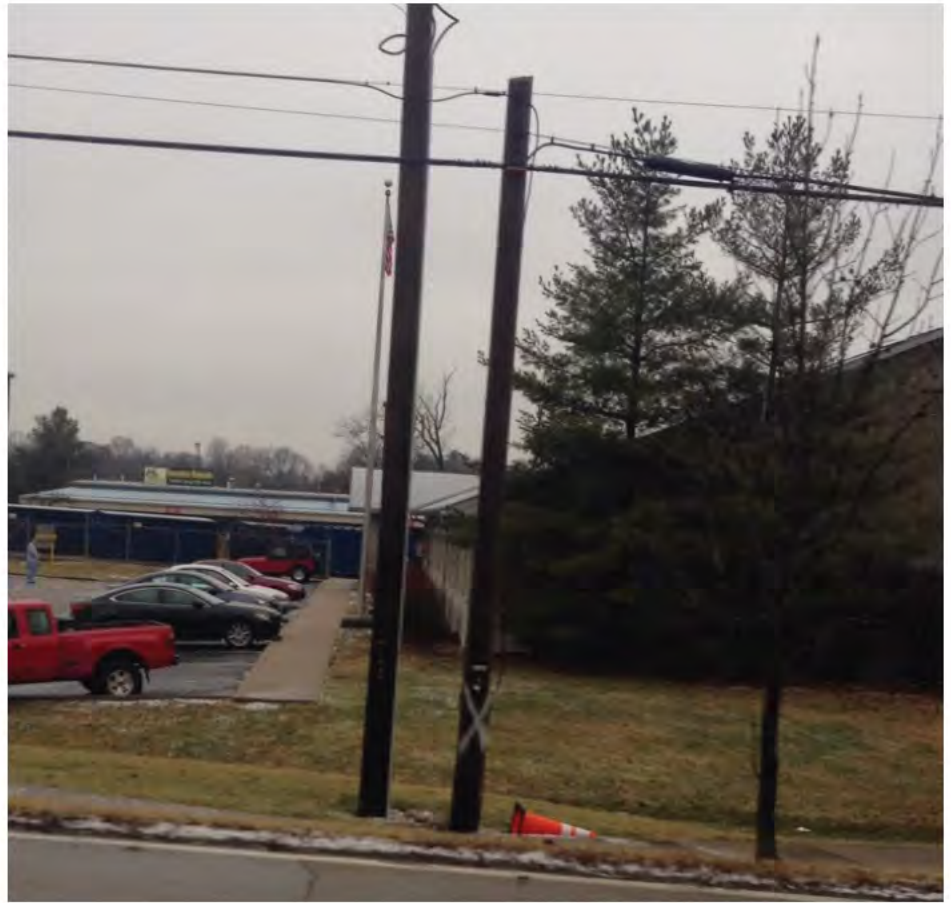
15. This photo from South Walnut Street, Bloomington, IN, shows a double-pole. The old pole (right, with a white spray-painted X) has only AT&T equipment attached to it. AT&T has not moved its facilities to the new utility pole. As a result, AT&T's equipment remains connected to an old, deteriorating pole, causing potential service and safety concerns.

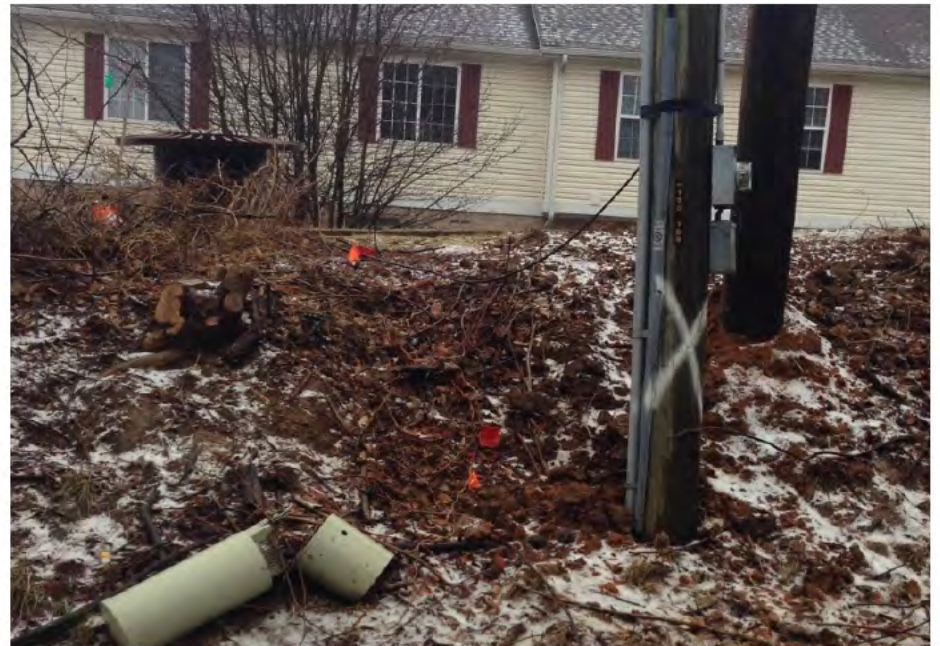
16. This photo from East 10th Street, Bloomington, IN, shows a damaged pedestal on its side next to a public street. Wires are exposed to damage from weather and animals. Damaged wires cause service outages. In addition, the exposed wires are a public safety hazard.

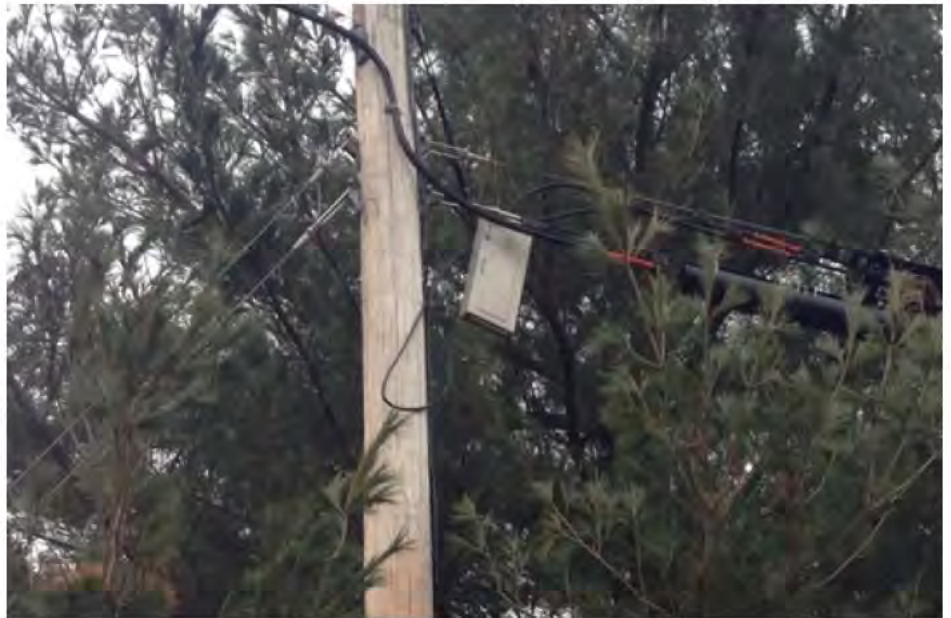
17. This photo from Sandpit Road, Bedford, IN, shows an unsecured terminal hanging from service wires. The terminal should be secured to the pole. The terminal can fill with water, deteriorating wires and leading to service issues. A hanging terminal presents a public safety hazard.

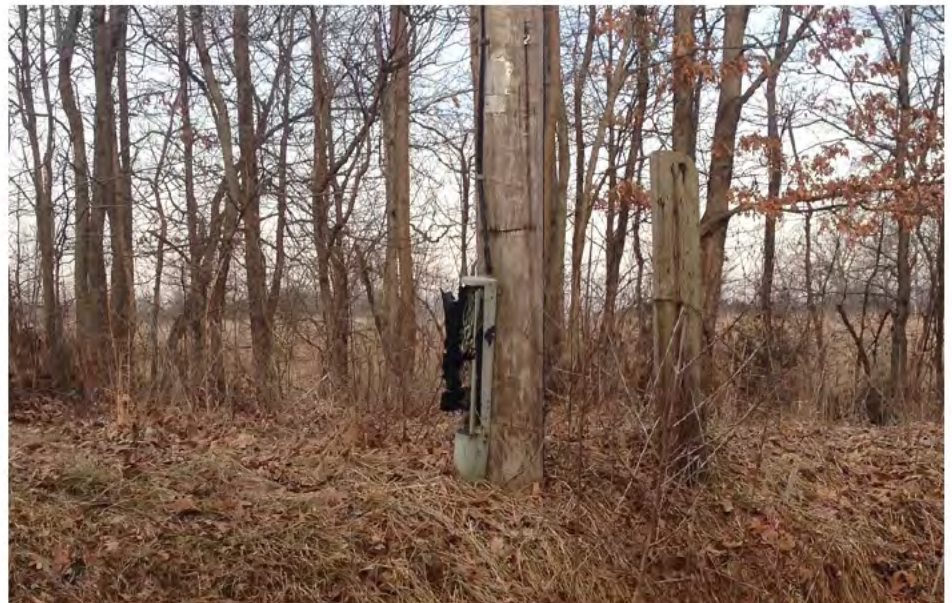
18. This photo from SR 135, Nashville, IN, shows a damaged pedestal. Its protective cover is missing. Wires are exposed to damage from weather and animals. Damaged wires cause service outages. In addition, the exposed wires are a public safety hazard.

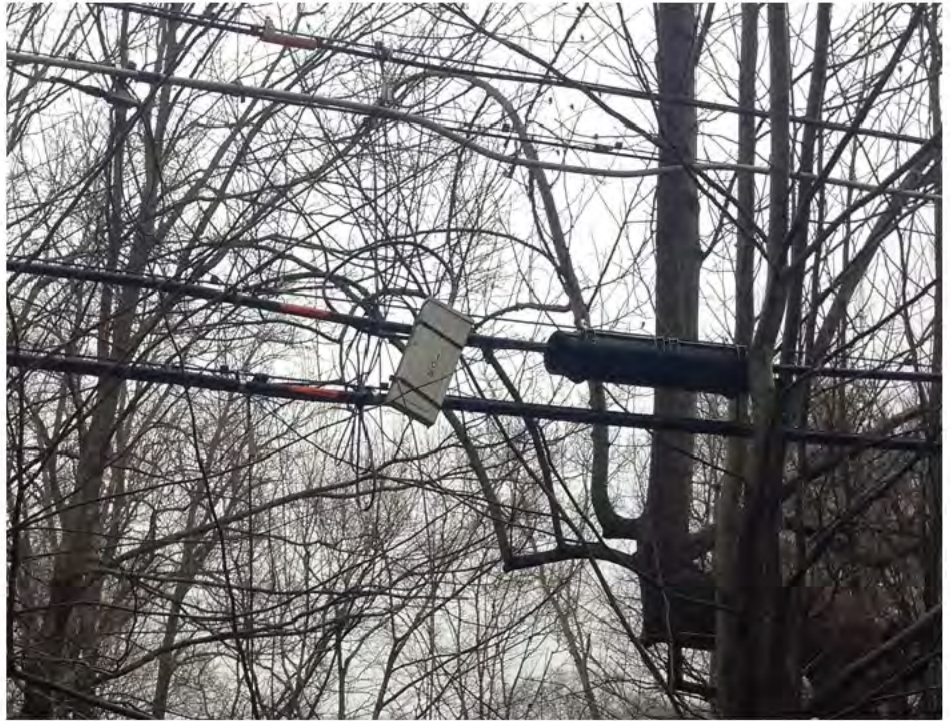
19. This photo from Bloomington, IN, shows an unsecured terminal. The terminal should be secured to the pole, not tied to the cable. The terminal can fill with water, deteriorating wires and leading to service issues. In addition, the terminal is wrapped shut with electrical tape, which is not designed to keep a terminal shut. This presents a serious public safety hazard.

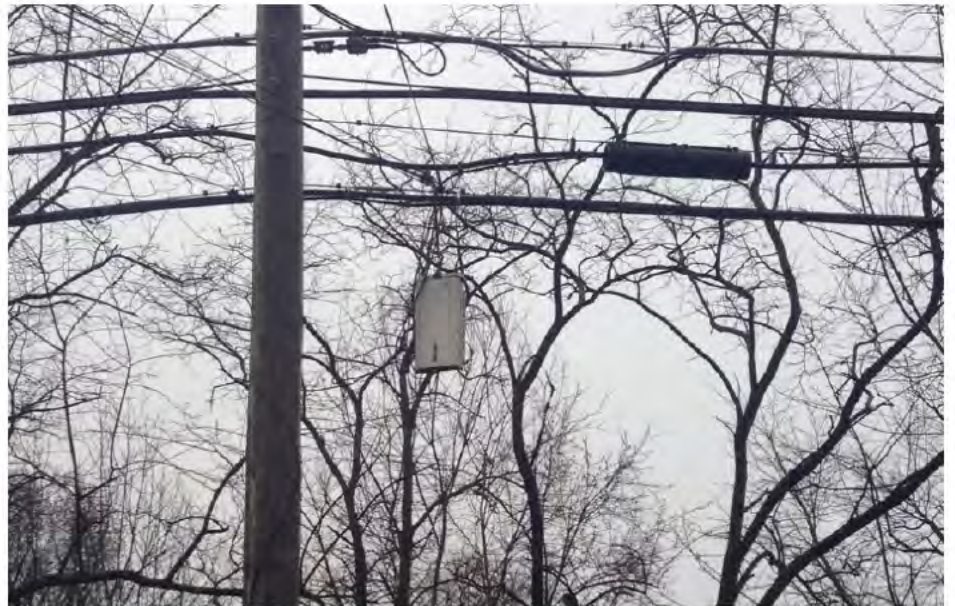
20. This photo from Bloomington, IN, shows an unsecured terminal hanging from service wires. The terminal should be secured to the pole. The terminal can fill with water, deteriorating wires and leading to service issues. In addition, a hanging terminal presents a public safety hazard.

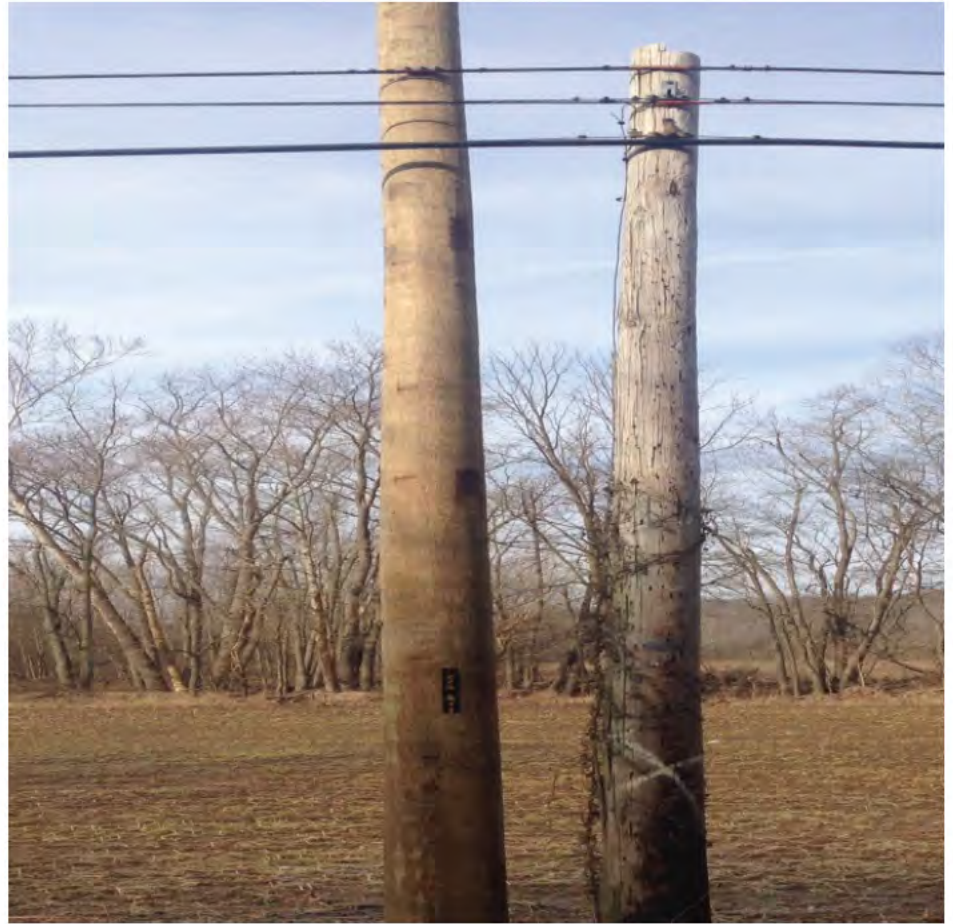
21. This photo from Claylick Road, Nashville, IN, shows a double-pole. The old pole (right, with a white spray-painted X) has only AT&T equipment attached to it. AT&T has not moved its facilities to the new utility pole. As a result, AT&T's equipment remains connected to old, deteriorating poles, causing potential service and safety concerns.

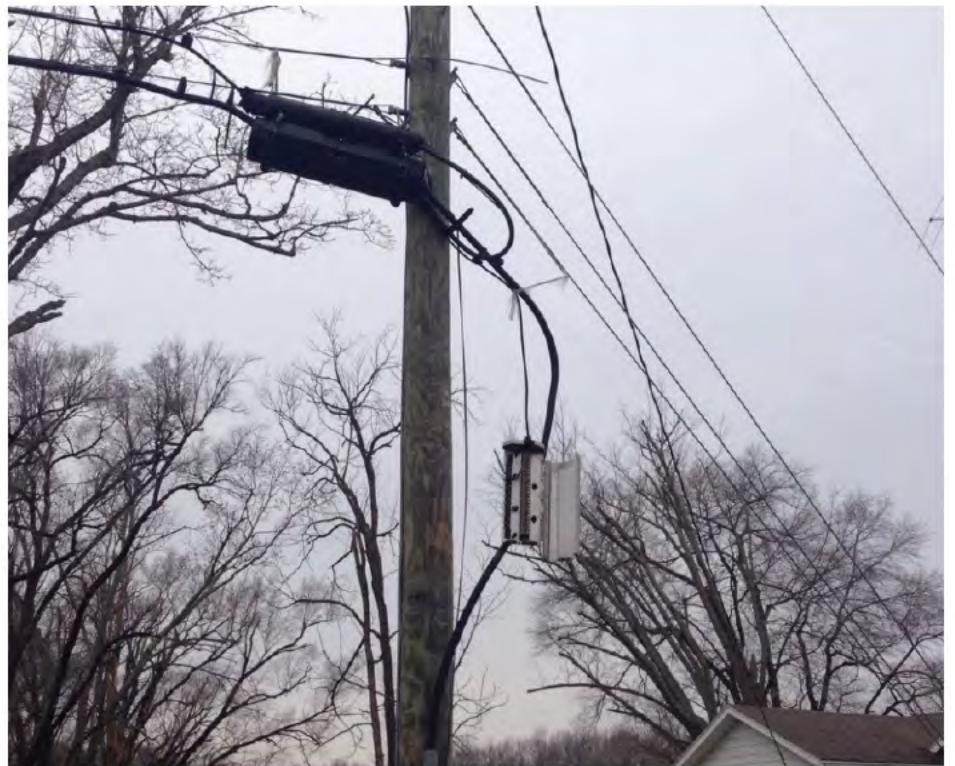
22. This photo from Diamond Road, Heltonville, IN, shows an unsecured terminal hanging from service wires. The terminal should be secured to the pole. The terminal case is also open, exposing wires to water. Water deteriorates the wires, leading to service issues. In addition, a hanging terminal presents a public safety hazard.

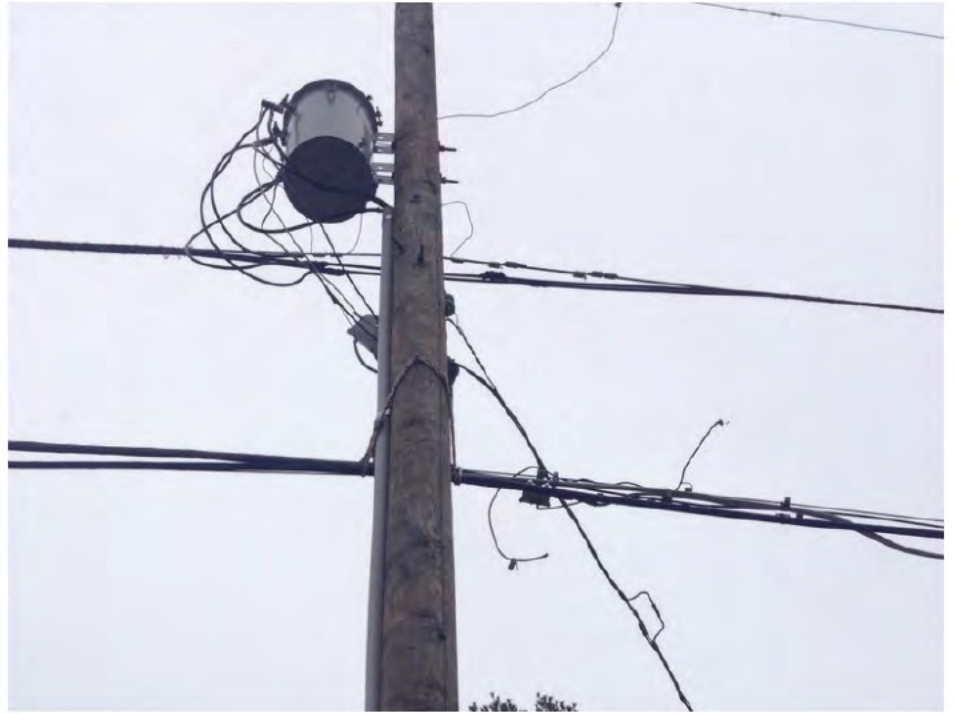
23. This photo from Tunnelton Road, Nashville, IN, shows improperly secured wires. The wires are tied around the utility pole. They will eventually deteriorate, leaving the wires unsecured. The wind blows the unsecured wires, damaging the copper inside the wire and causing service issues.
