AT&T:
Abandoning Rural & Other
Communities in Michigan

AT&T Copper Plant Photos – Michigan

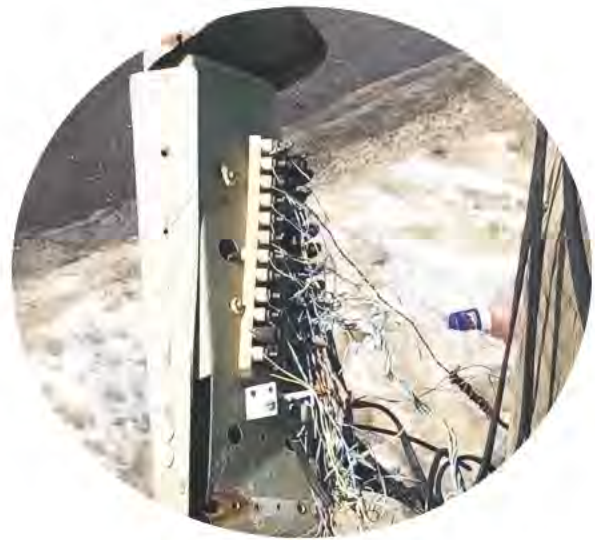
CWA, as part of its on-going obligation to its members, conducted an investigation at AT&T facilities serviced by CWA members. The investigation focused on the condition of outside plant (readily observable from public streets and sidewalks) in rural and suburban areas of Michigan. In the course of its investigation, CWA uncovered numerous instances of facilities throughout Michigan in a dangerous state of disrepair that pose service and safety hazards. CWA has documented some of the most blatant effects of these

practices and policies through photographs of AT&T facilities in plain sight from public areas throughout AT&T's service area.

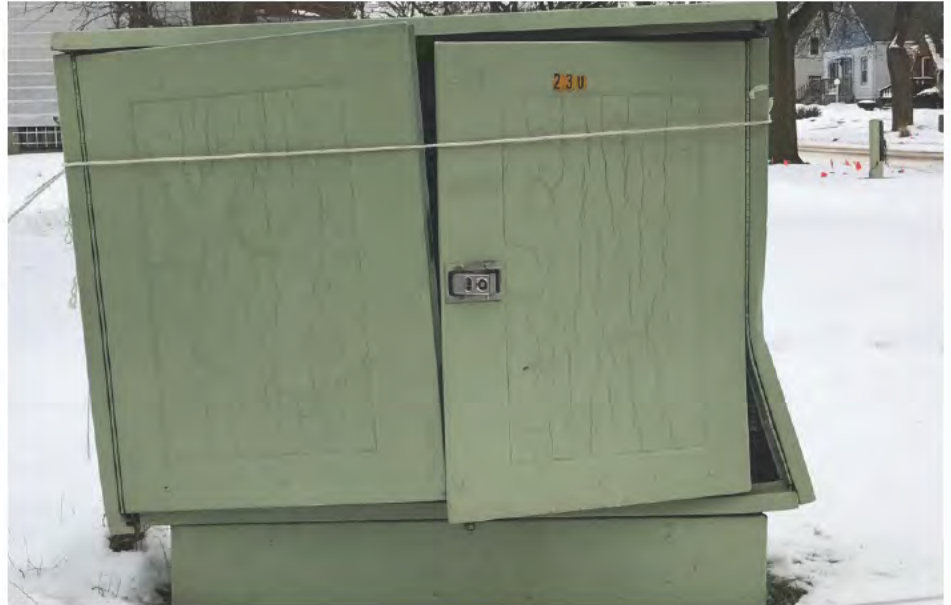
1. This photo from Dewey Street, Flint, MI, shows a damaged cross-connect box. The box's protective case is damaged and its doors held partially closed with rope. Internal wires are exposed to weather and animals. Damaged wires cause service outages. In addition, the exposed wires are a public safety hazard.

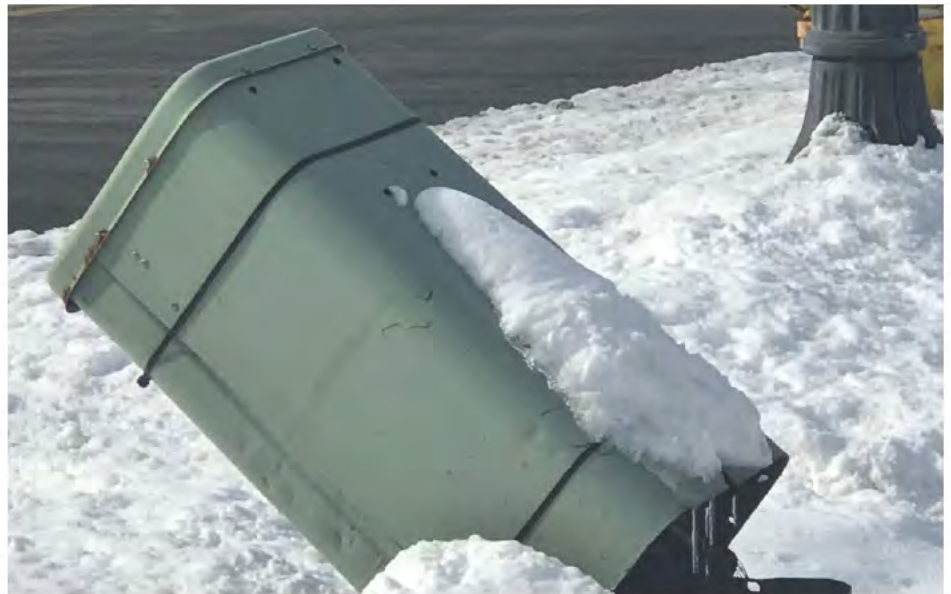
2. This photo from East Main Street, Flushing, MI, shows a damaged pedestal. Its protective cover is damaged, leaving wires exposed to damage from weather and animals. Damaged wires cause service outages. In addition, the exposed wires are a public safety hazard.

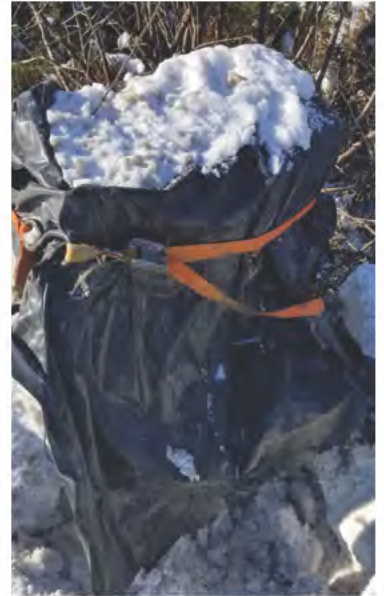
3. This photo from South Main Street, Lapeer, MI, shows a damaged cross-connect box. Instead of replacing the box, AT&T covered it with a black plastic cover. This cover will fall off or deteriorate, leaving wires exposed to weather and animals. Damaged wires cause service outages. In addition, the exposed wires are a public safety hazard.

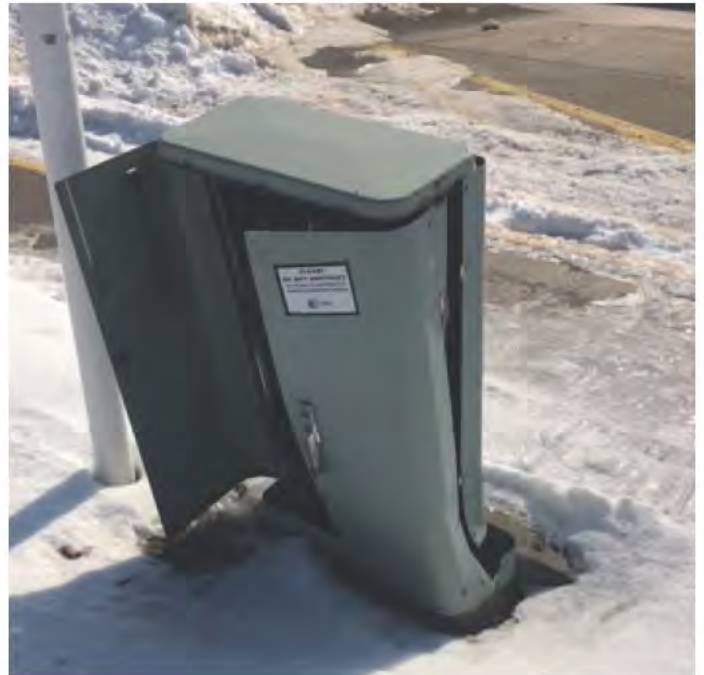
4. This photo from North Center Drive, Grand Rapids, MI, shows a damaged cross-connect box. The box's protective case is damaged and its doors left open. Internal wires are exposed to weather and animals. Damaged wires cause service outages. In addition, the exposed wires are a public safety hazard.

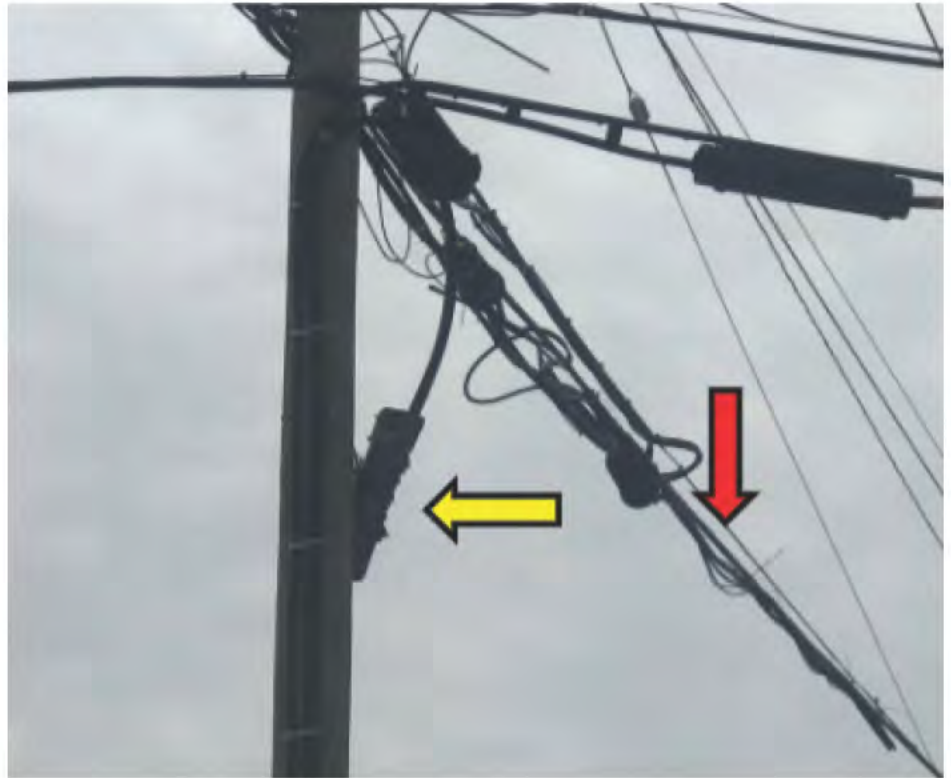
5. This photo from South Lapeer Road, Oxford, MI, shows an unsecured splice terminal and damaged cable. The terminal should be secured to cable, not left hanging (yellow arrow). And cable should be secured to the utility pole (yellow arrow). In addition, AT&T used drop wires (red arrow) to bypass sections of bad cable.

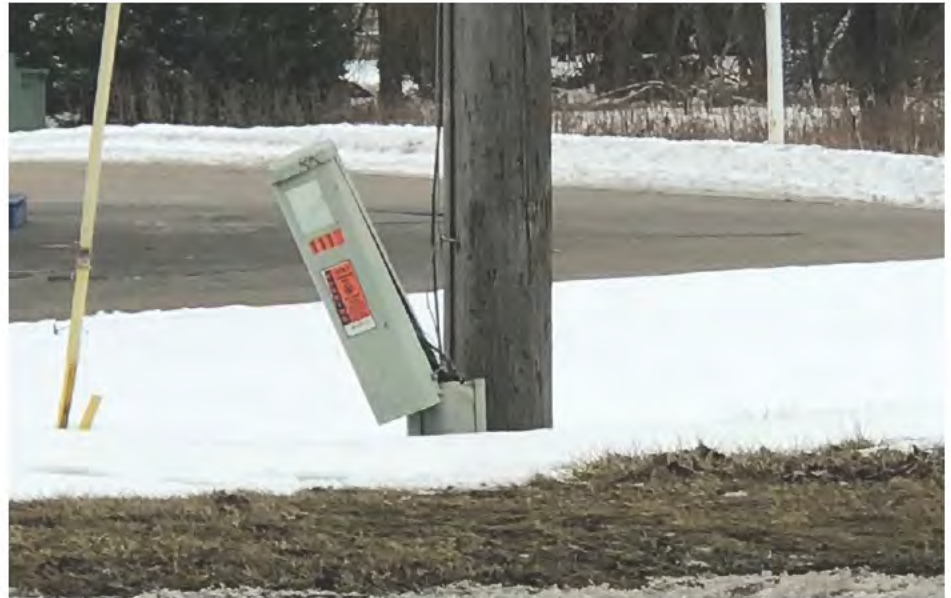
6. This photo from South Belsay Road, Burton, MI, shows a damaged pedestal. Its protective cover is damaged, leaving wires exposed to damage from weather and animals. Damaged wires cause service outages. In addition, the exposed wires are a public safety hazard.

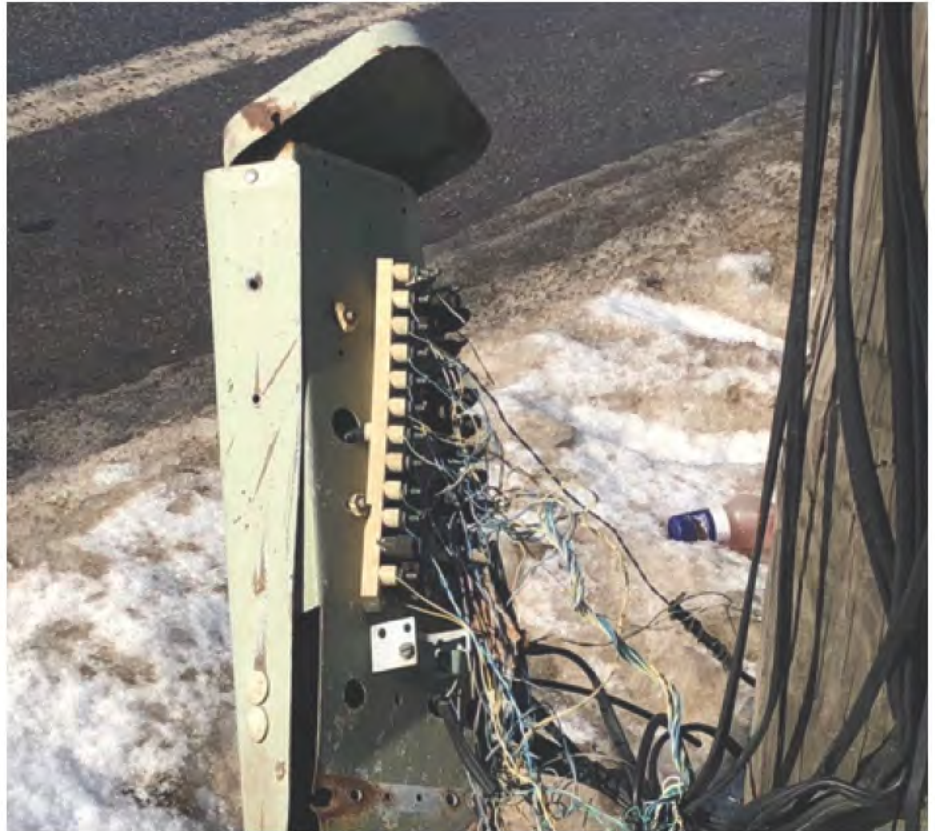
7. This photo from Alpine Avenue, Grand Rapids, MI, shows a severely damaged pedestal. Its protective cover is missing, leaving wires exposed to damage from weather and animals. Damaged wires cause service outages. In addition, exposed wires are a public safety hazard.

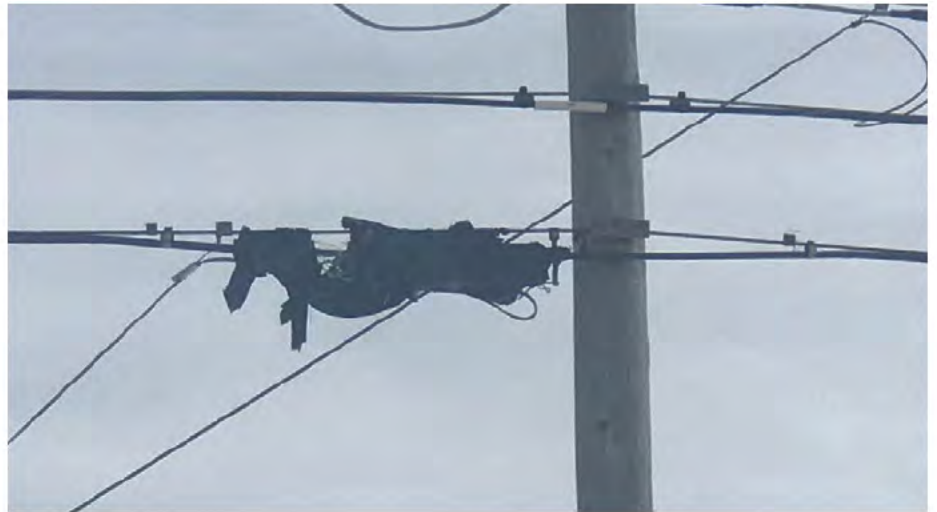
8. This photo from Elms Road, Flint, MI, shows a severely damaged splice terminal. The terminal's protective case is hanging open, and the black plastic covering meant to protect wires has deteriorated, leaving wires exposed to weather and animals. Damaged wires cause service outages.

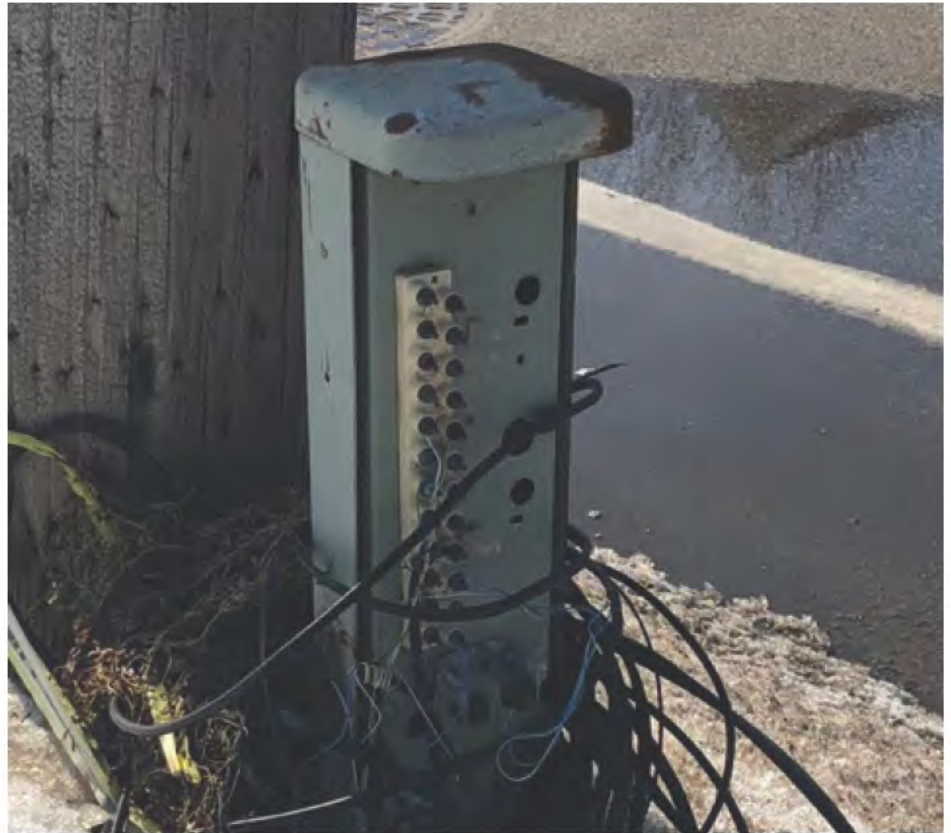
9. This photo from Alpine Avenue, Grand Rapids, MI, shows a severely damaged pedestal. Its protective cover is missing, leaving wires exposed to damage from weather and animals. Damaged wires cause service outages. In addition, exposed wires are a public safety hazard.

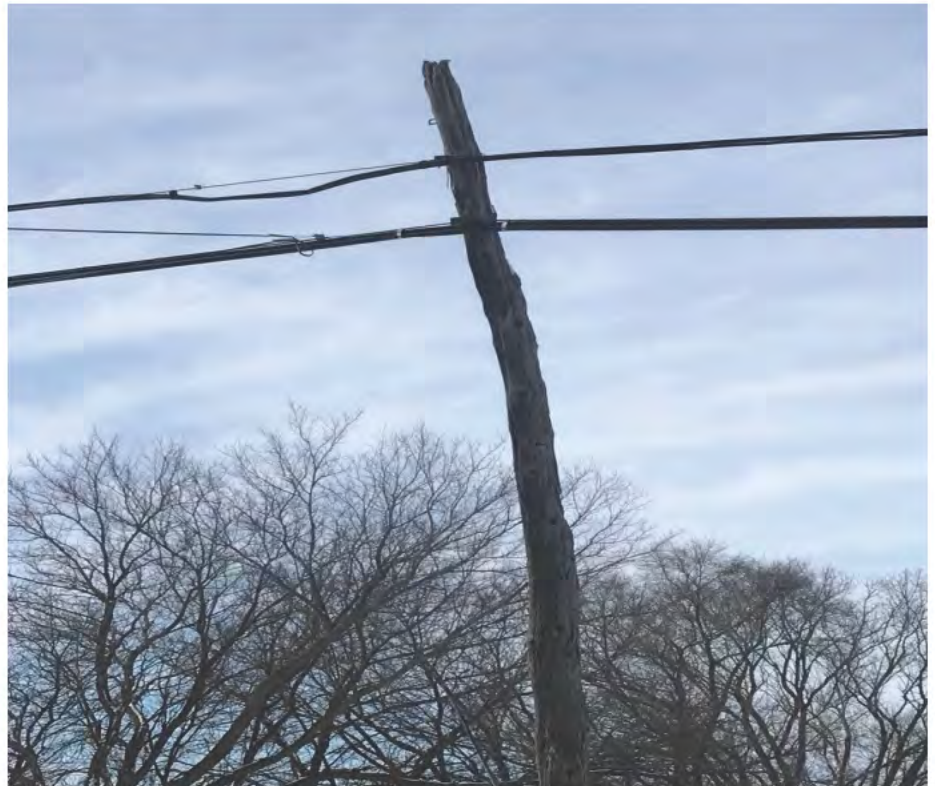
10. This photo from Seymour Road, Flint, MI, shows a rotting pole. AT&T's equipment is the only equipment that remains. AT&T has not moved its facilities to a new utility pole. As a result, AT&T's equipment remains connected to an old, deteriorating pole, causing potential service and safety concerns.

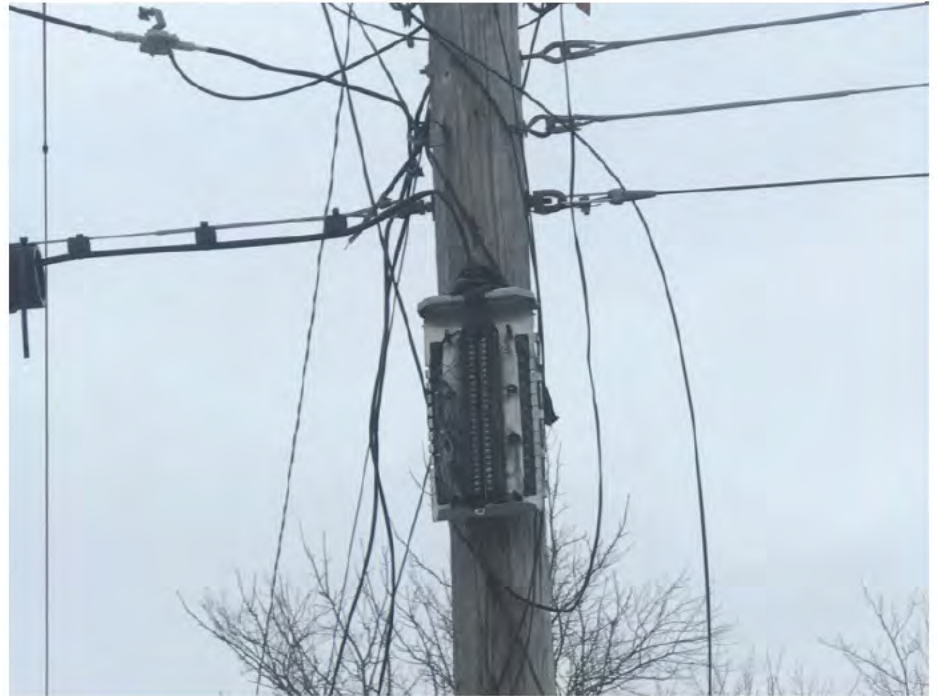
11. This photo from Dixie Highway, Waterford, MI, shows a damaged terminal. The terminal's protective case is missing, leaving wires exposed to weather and animals. Damaged wires cause service outages.

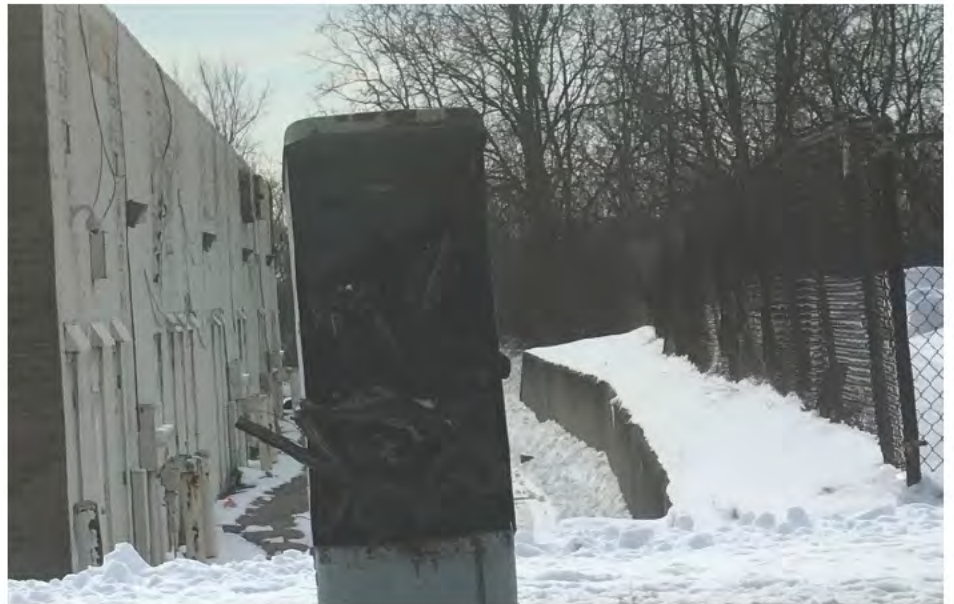
12. This photo from Miller Road, Flint, MI, shows a severely damaged pedestal. Its protective cover is missing, leaving wires exposed to damage from weather and animals. Damaged wires cause service outages. In addition, exposed wires are a public safety hazard.

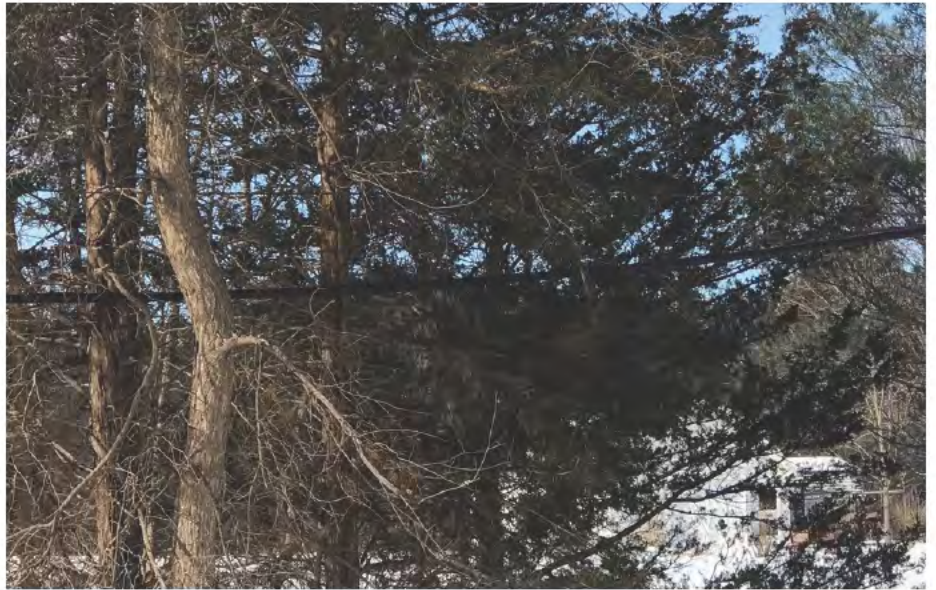
13. This photo from Seymour Road, Flushing, MI, shows a cable supported by a tree. Cables should be secured to utility poles, not resting on a tree. The wind blows the unsecured service cable, damaging the copper wire and causing service issues or causing it to fall.

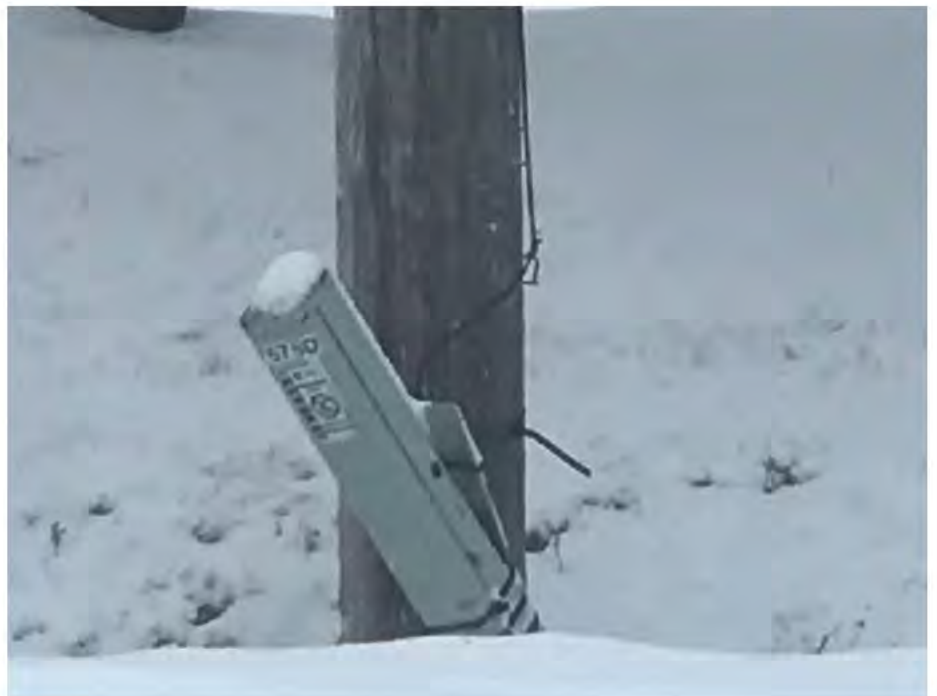
14. This photo from Dixie Highway, Frankenmuth, MI, shows a damaged pedestal. Its protective cover is open, leaving wires exposed to damage from weather and animals. Damaged wires cause service outages. In addition, exposed wires are a public safety hazard.

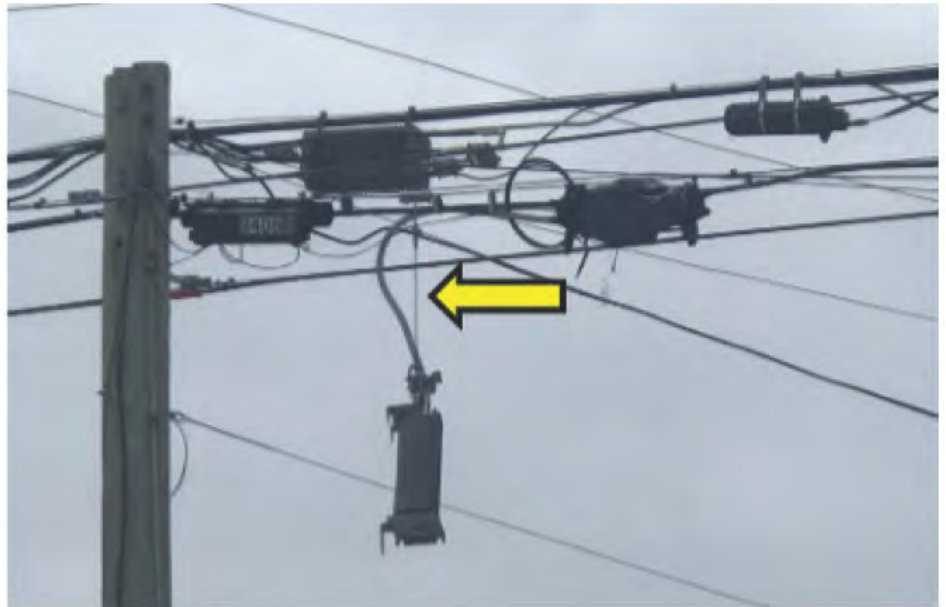
15. This photo from Dixie Highway, Clarkston, MI, shows an unsecured load pot hanging from a cable. Load pots weigh hundreds of pounds and should be secured to the pole. This load pot appears to be supported by a rope (yellow arrow). An unsecured load pot is a safety risk and will result in service issues.

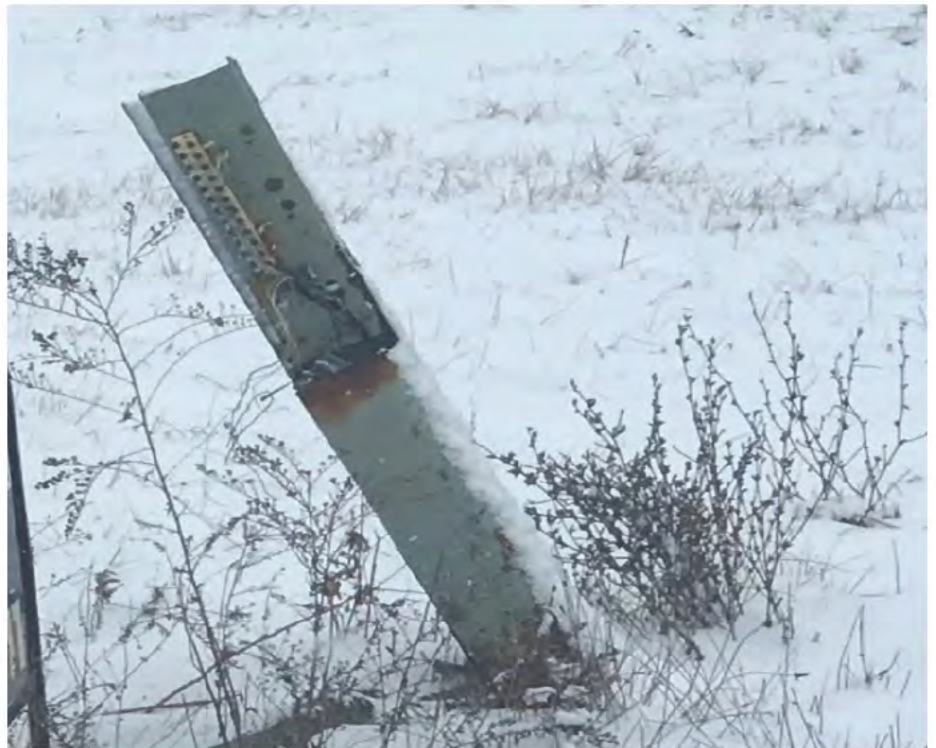
16. This photo from Dixie Highway, Birch Run, MI, shows a severely damaged pedestal. Its protective cover is missing, leaving wires exposed to damage from weather and animals. Damaged wires cause service outages. In addition, exposed wires are a public safety hazard.

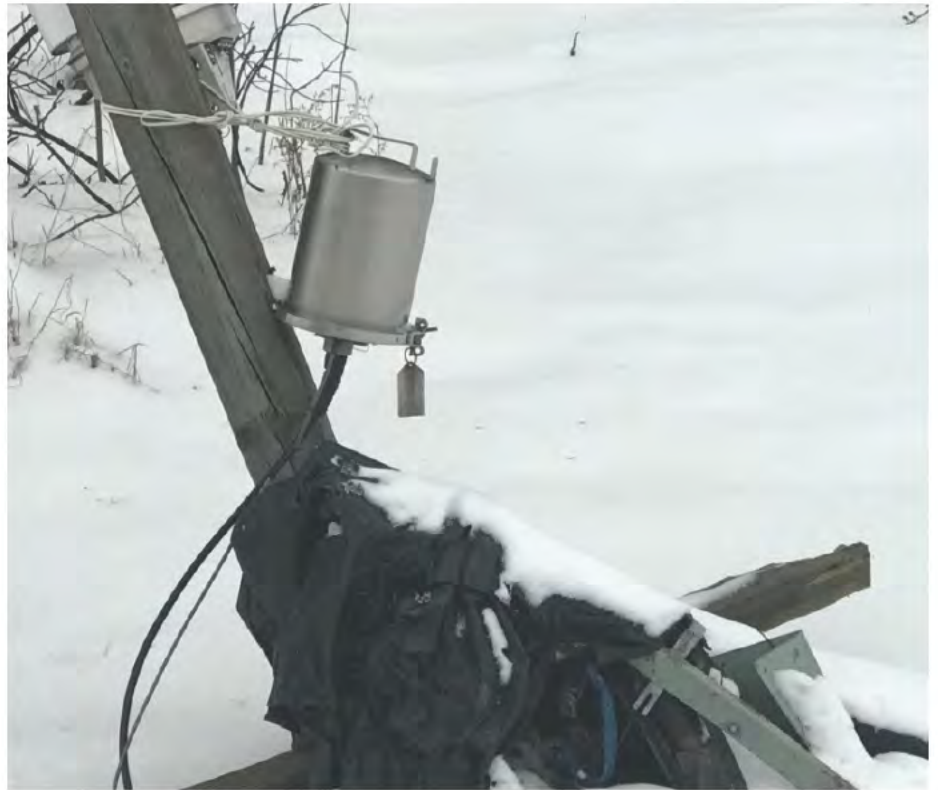
17. This photo from Jennings Road, Fenton, MI, shows a damaged terminal. Instead of replacing the terminal, AT&T covered it with a black plastic cover. This cover is falling off and will deteriorate, leaving wires exposed to weather and animals. Damaged wires cause service outages. In addition, the exposed wires are a public safety hazard.

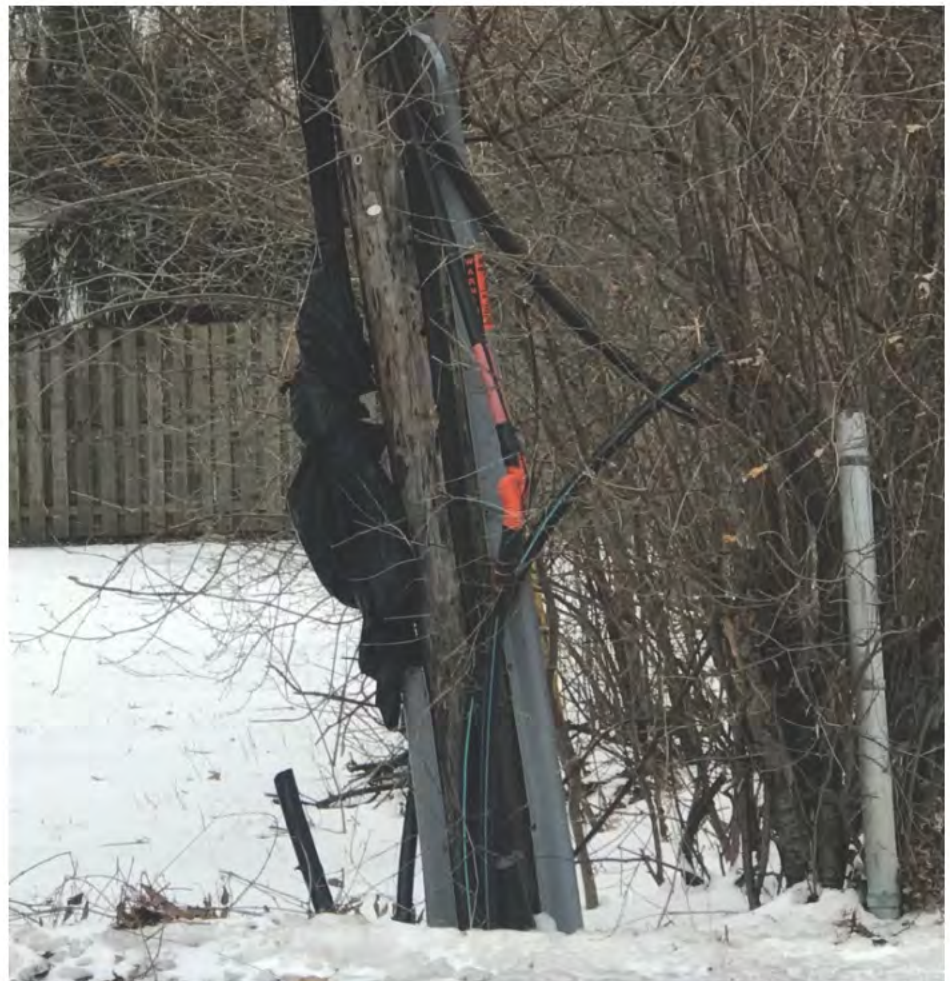
18. This photo from West 13 Mile, Southfield, MI, shows a deteriorated pole and damaged cable. Rather than replacing the cable, AT&T cut a black plastic bag to cover it. This cover will fall off, leaving wires exposed to weather and animals. Damaged wires cause service outages.

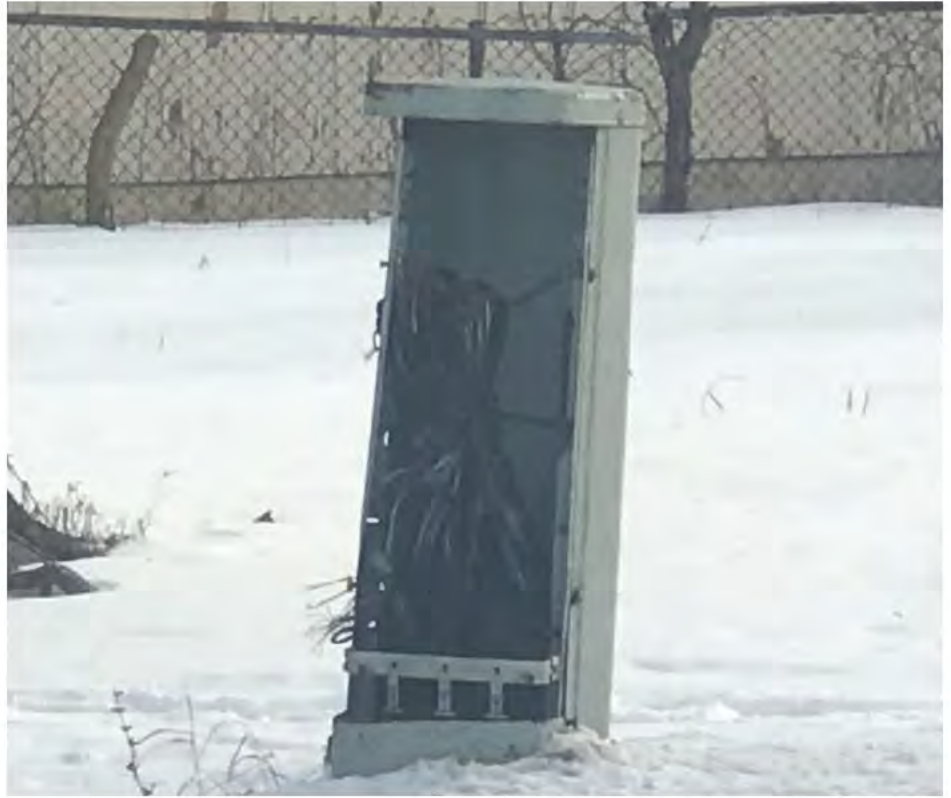
19. This photo from South Ballenger Highway, Flint, MI, shows a severely damaged pedestal. Its protective cover is missing, leaving wires exposed to damage from weather and animals. Damaged wires cause service outages. In addition, exposed wires are a public safety hazard.

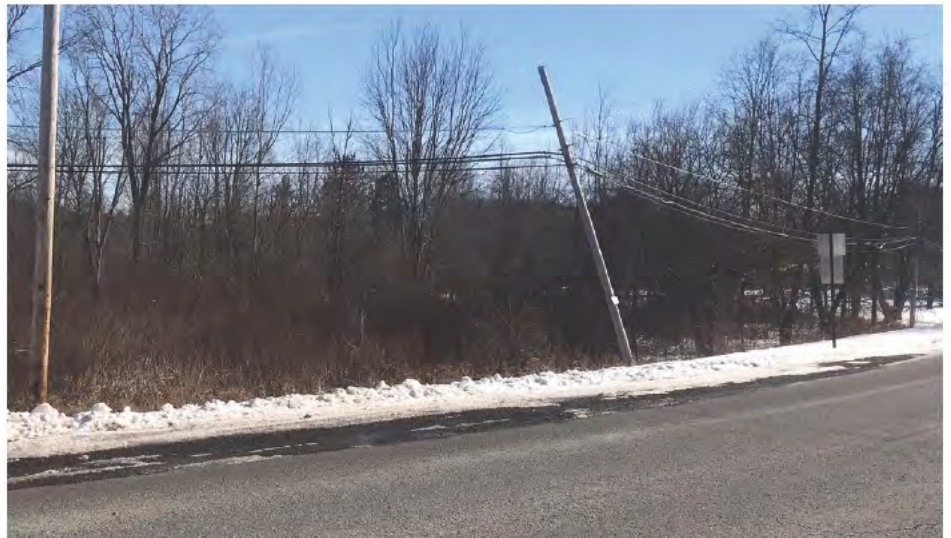
20. This photo from Byron Road, Byron, MI, shows a damaged, leaning utility pole. The old pole is significantly damaged and leaning, putting strain on AT&T's cables and equipment, which remain attached. Despite the state of this utility pole, AT&T has not moved its facilities to a new pole. As a result, AT&T's equipment remains connected to an old, damaged pole, causing potential service and safety concerns.

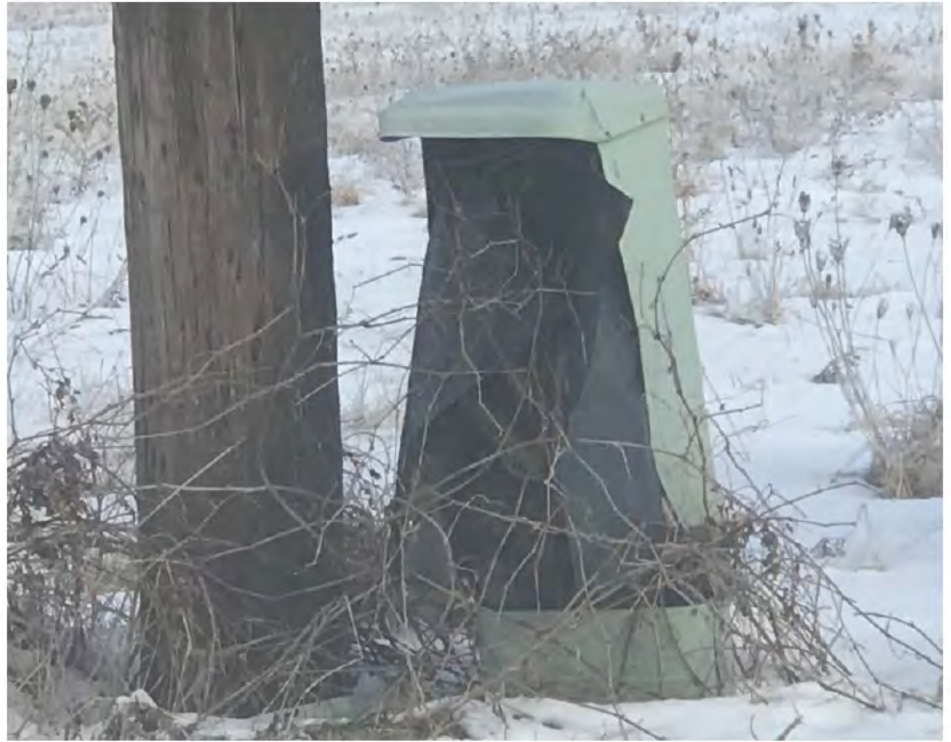
21. This photo from Linden Road, Flint, MI, shows a damaged pedestal. Its protective cover is missing, leaving wires exposed to weather and animals. Damaged wires cause service outages. In addition, the exposed wires are a public safety hazard.
