AT&T:
Abandoning Rural & Other
Communities in Ohio

AT&T Copper Plant Photos – Ohio

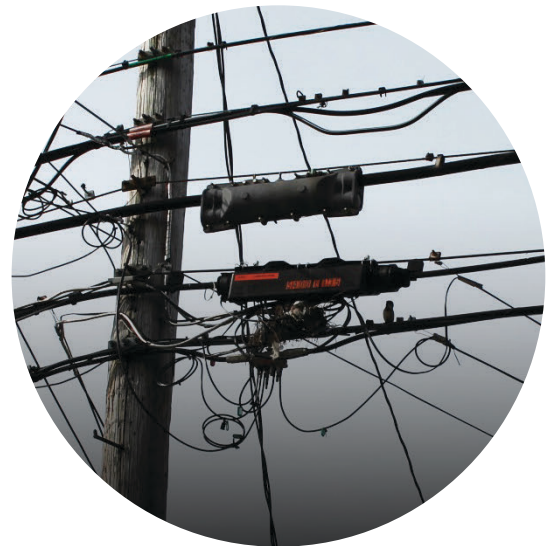
1. This photo from Lafayette Street, Youngstown, OH, shows a severely damaged splice terminal. The terminal's protective case is completely deteriorated, leaving wires exposed to weather and animals. Damaged wires cause service outages.

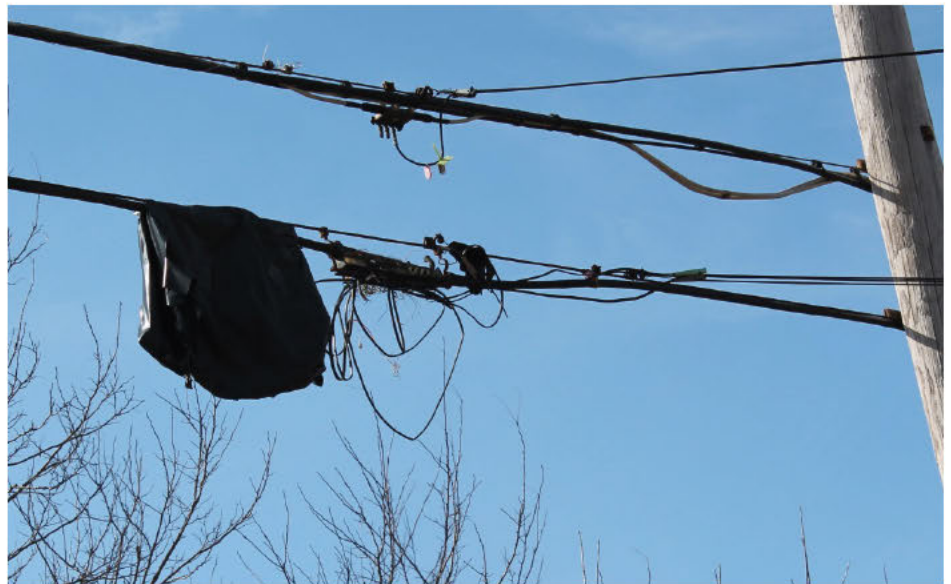
2. This photo from Delaware Avenue, Youngstown, OH, shows a severely damaged splice terminal. The terminal's protective case is hanging open, and the black plastic covering meant to protect wires has fallen off, leaving wires exposed to weather and animals. Damaged wires cause service outages.

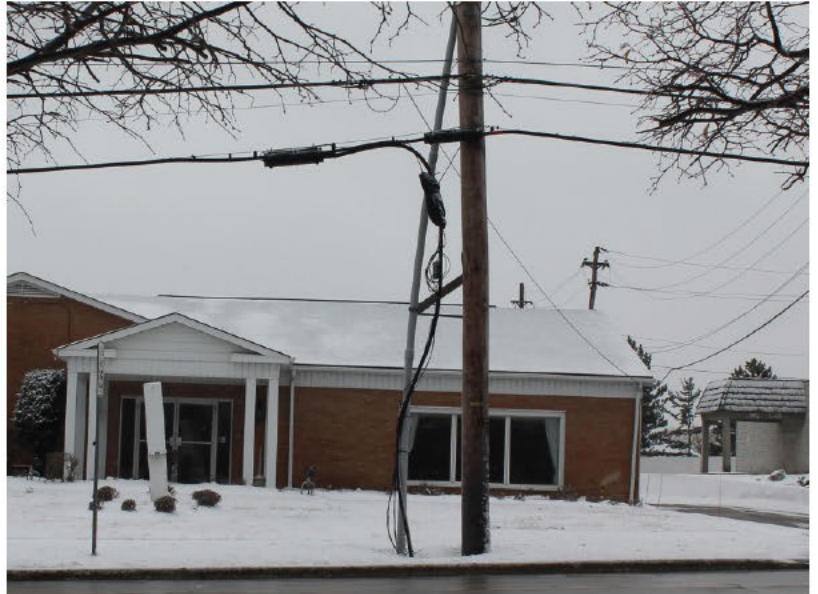
3. This photo from Emery Road, Warrensville Heights, OH, shows unsecured cable. The cable should be secured to the utility pole. The wind blows the unsecured service cable, damaging the copper inside the wire and causing service issues. In addition, this cable is within reach of passersby, causing a public safety hazard.

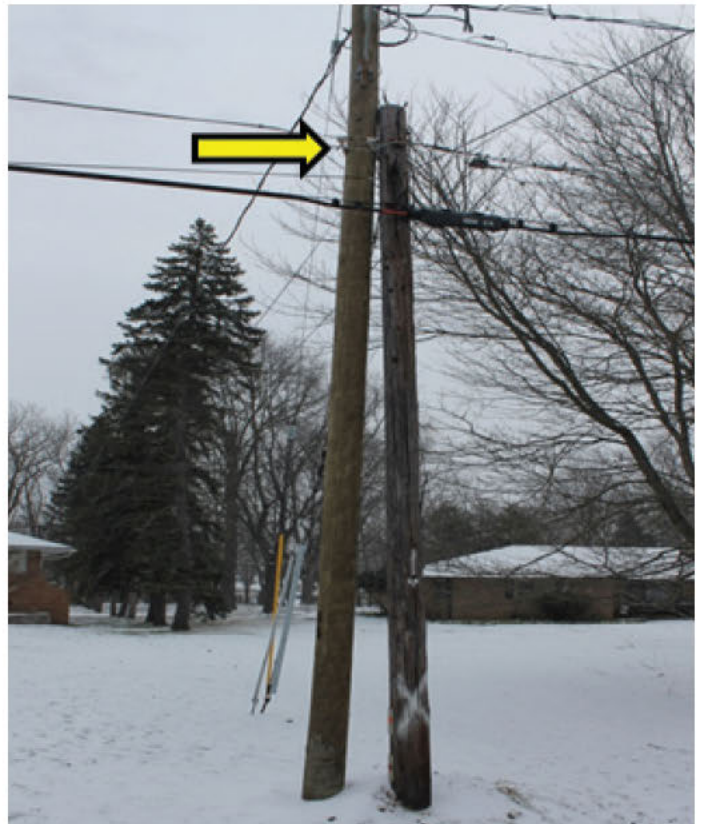
4. This photo from North Linden Lane, Parma, OH, shows a double-pole. The old pole (right, with a white spray-painted X) with only AT&T equipment attached to it is tied to the new pole with rope (yellow arrow) to prevent it from falling. AT&T has not moved its facilities to the new utility pole. As a result, AT&T's equipment remains connected to an old, deteriorating pole, causing potential service and safety concerns.

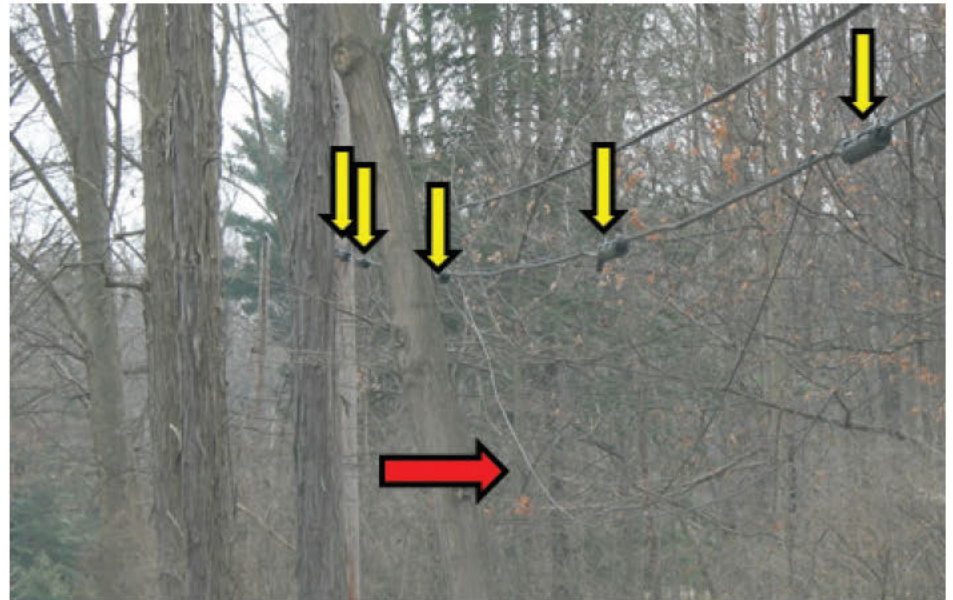
5. This photo from Hillcreek Lane, Gates Mills, OH, shows a badly damaged cable. Instead of replacing the cable, AT&T spliced the cable at least five times on a short strand of cable (yellow arrows). In addition, AT&T used drop wires (red arrow) to bypass sections of bad cable.

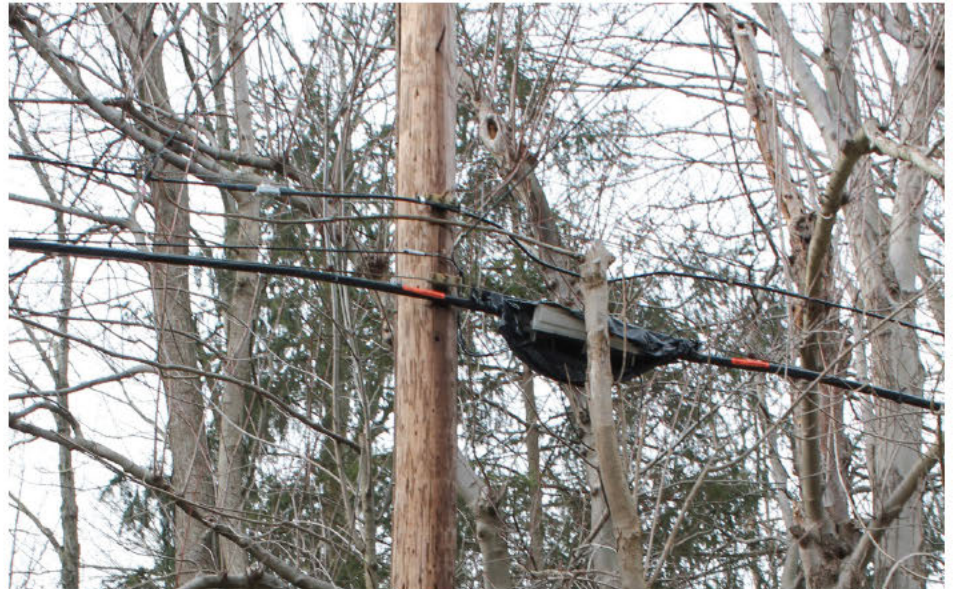
6. This photo from Gates Road, Gates Mills, OH, shows a damaged splice wrapped in a black plastic covering. Once the wrap deteriorates, wires are exposed to weather and animals. Damaged wires cause service outages.

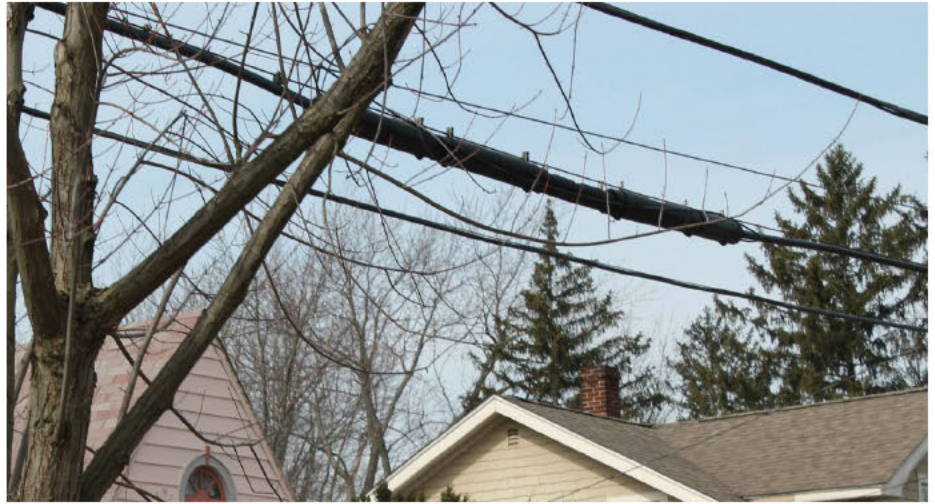
7. This photo from Charles Street, Maple Heights, OH, shows a badly damaged cable. Instead of replacing the cable, AT&T attempted to resolve the problem with multiple splices in a span of a few feet on the cable. Each splice box covers a portion of damaged or defective cable.

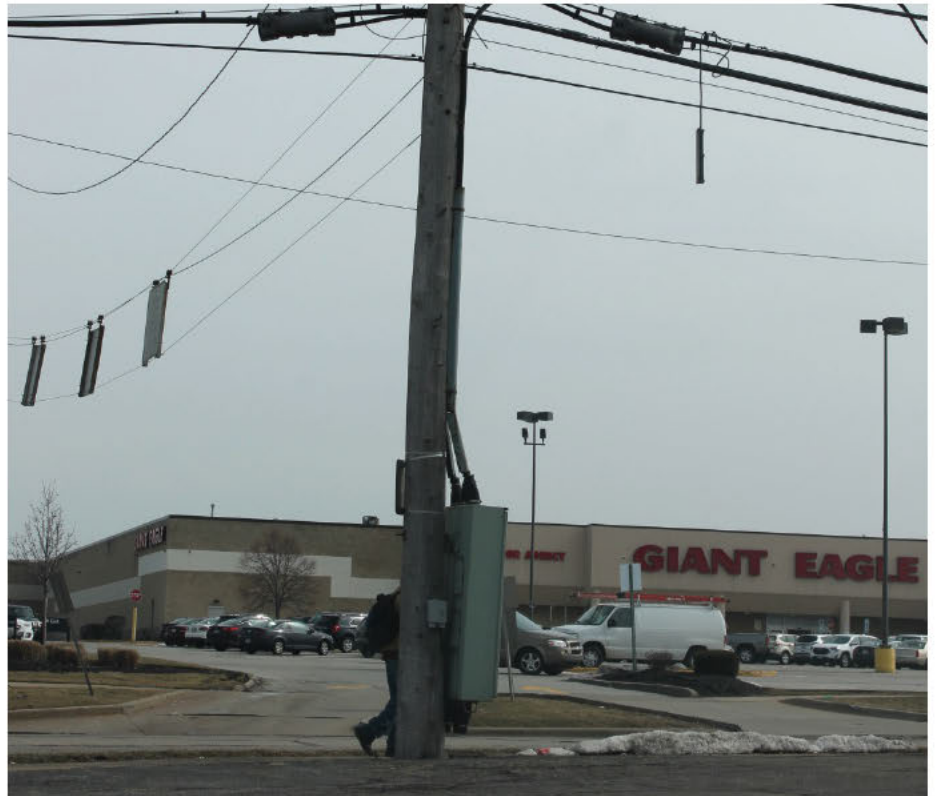
8. This photo from Warrensville Center Road, Maple Heights, OH, shows an unsecured terminal hanging from service wires. The terminal should be secured to the pole. The terminal can fill with water, deteriorating wires and leading to service issues. In addition, a hanging terminal presents a public safety hazard to passersby.

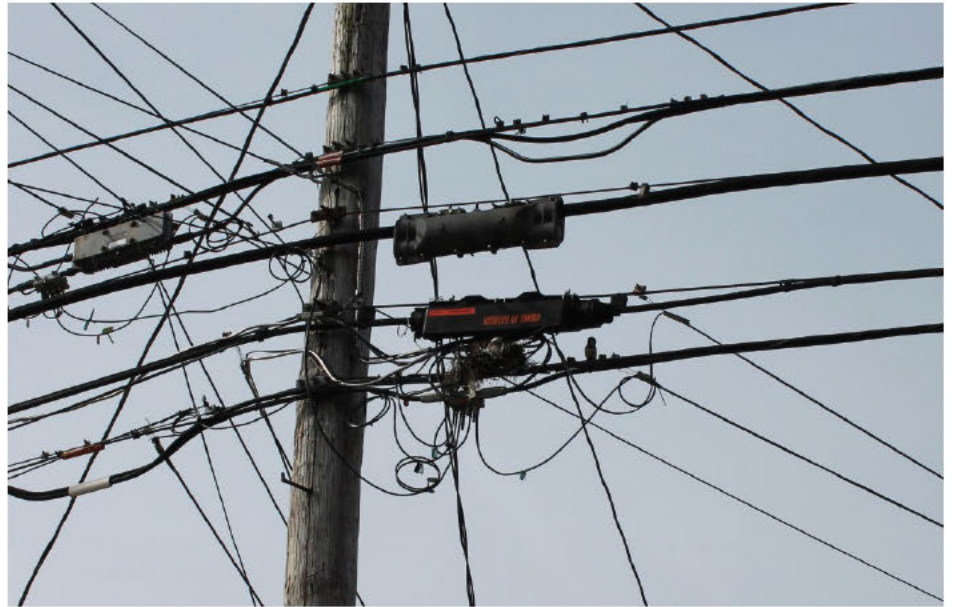
9. This photo from East 135th Street, Garfield Heights, OH, shows a severely damaged splice box. The box's protective case has deteriorated, leaving wires exposed to weather and animals. Damaged wires cause service outages.

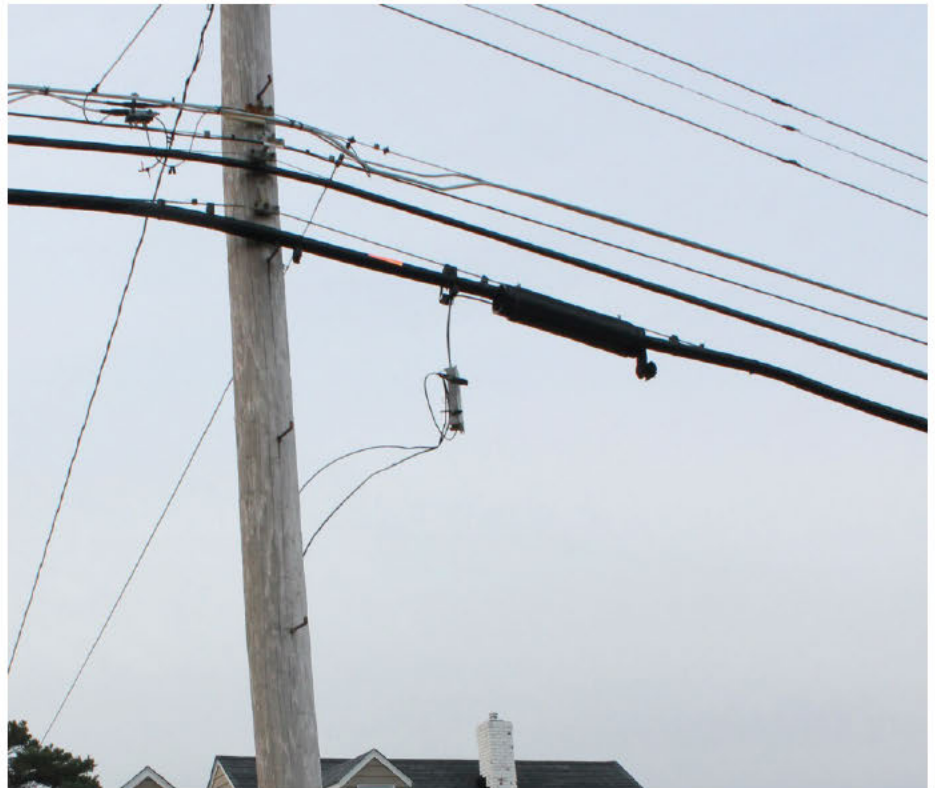
10. This photo from Evelyn Drive, Seven Hills, OH, shows an unsecured terminal hanging from service wires. The terminal should be secured to the pole. The terminal can fill with water, deteriorating wires and leading to service issues. In addition, a hanging terminal presents a public safety hazard.

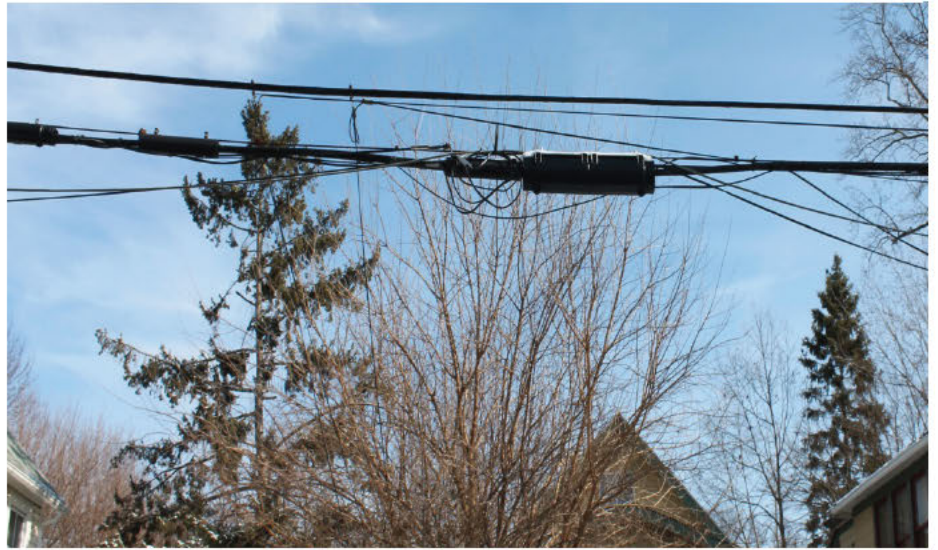
11. This photo from West 48th Street, Cleveland, OH, shows a badly damaged cable. Instead of replacing the cable, AT&T installed multiple splice boxes on the cable. Each splice box covers a portion of damaged or defective cable. AT&T also used thin drop wires to bypass sections of bad cable. Each of the numerous thin wires would have been installed in response to a separate customer complaint.

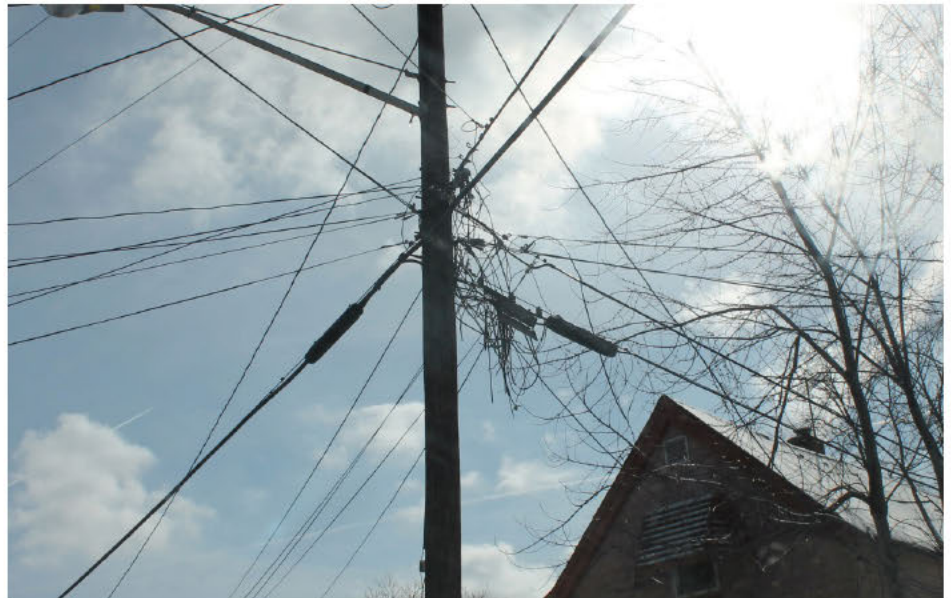
12. This photo from Brown Avenue, Newburgh Heights, OH, shows a severely damaged splice terminal. The terminal's protective case is hanging open, leaving wires exposed to weather and animals. Damaged wires cause service outages.

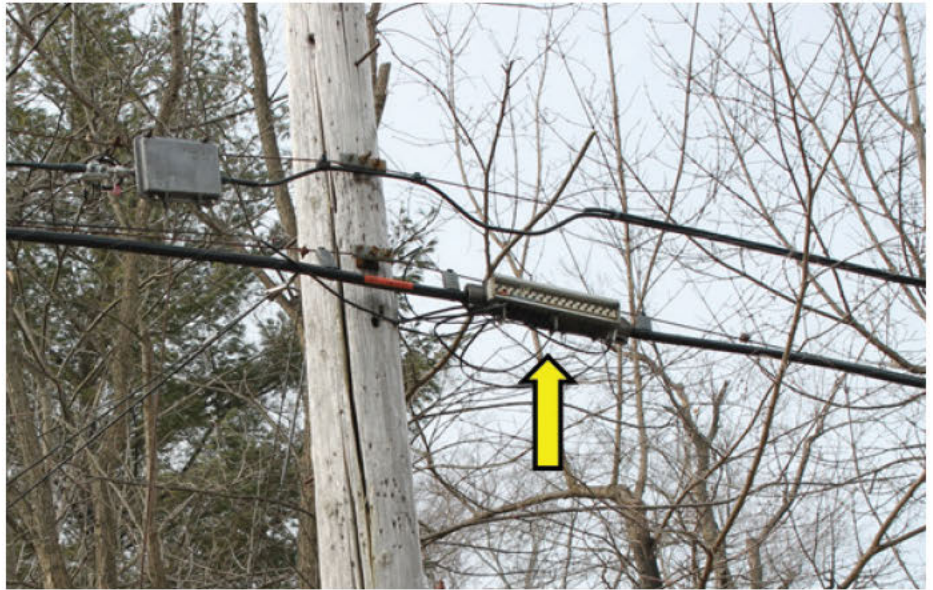
13. This photo from Forest Drive, Pepper Pike, OH, shows an exposed terminal (yellow arrow). The terminal's protective case is hanging open, leaving wires exposed to weather and animals. Damaged wires cause service outages.

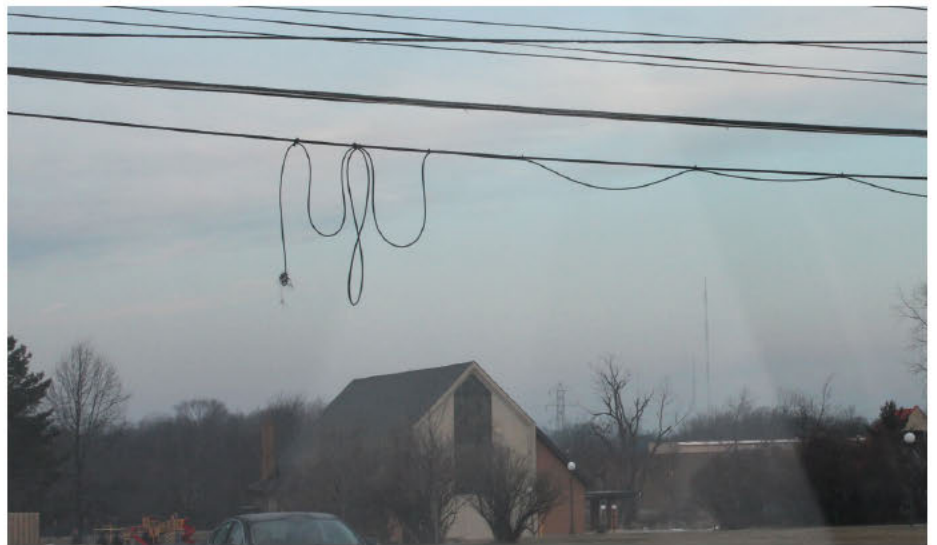
14. This photo from Broadview Road, Seven Hills, OH, shows a disconnected wire hanging above an intersection. The wire is secured to another wire, but the damaged wires are exposed to weather, leading to further degradation of the wire.

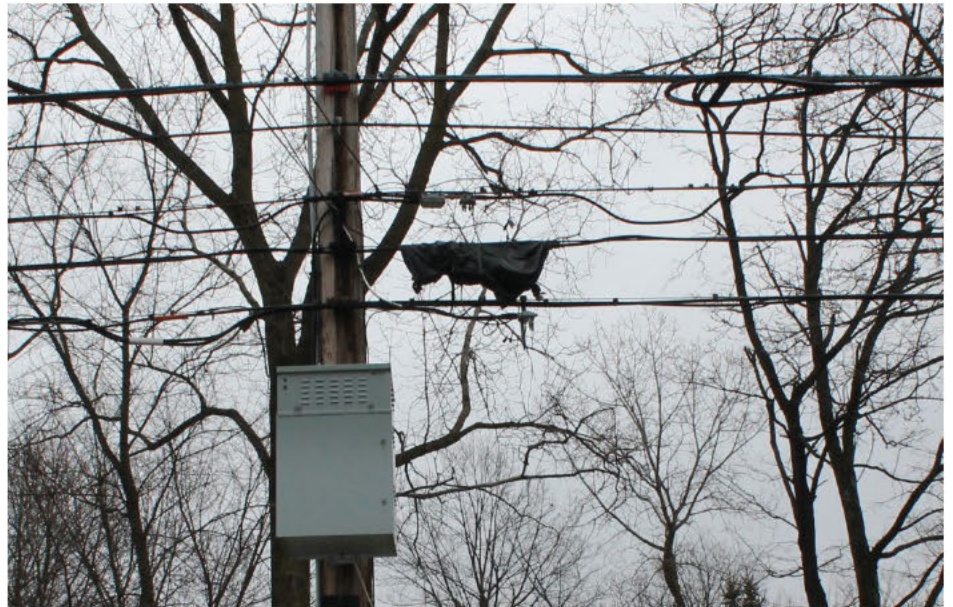
15. This photo from York Road, North Royalton, OH, shows a damaged splice wrapped in a black plastic covering. Once the wrap deteriorates, wires are exposed to weather and animals. Damaged wires cause service outages.

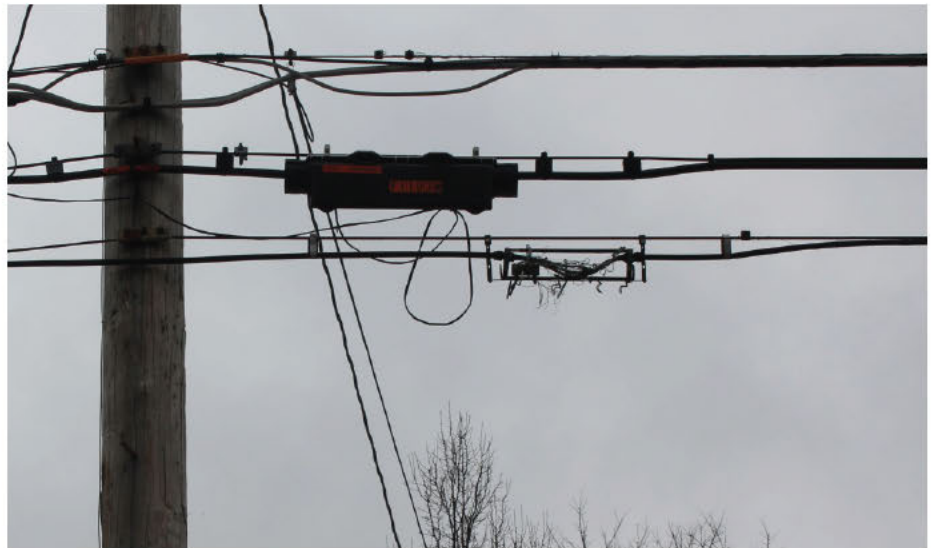
16. This photo from Wexford, Parma, OH, shows a severely damaged splice terminal. The terminal's protective case is missing, leaving wires exposed to weather and animals. Damaged wires cause service outages.

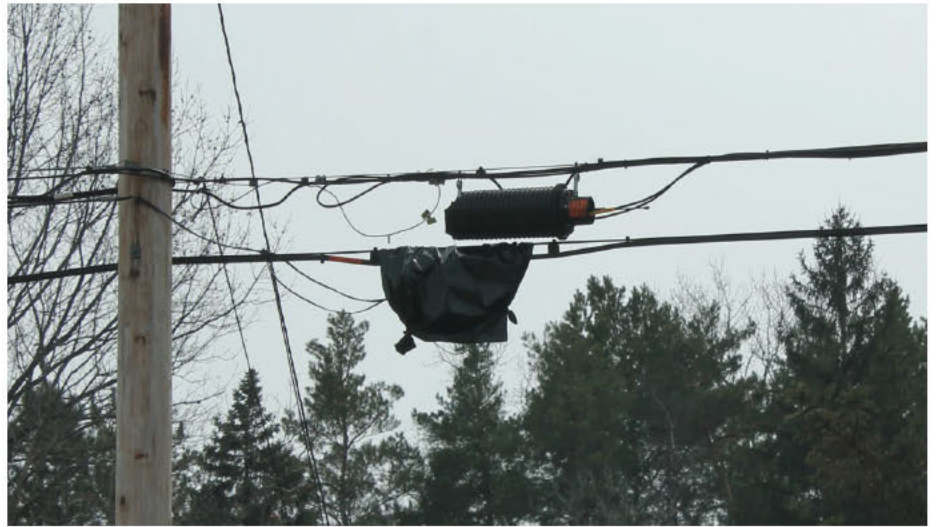
17. This photo from Emery Road, Chagrin Falls, OH, shows a damaged splice wrapped in a black plastic covering. Once the wrap deteriorates, wires are exposed to weather and animals. Damaged wires cause service outages.

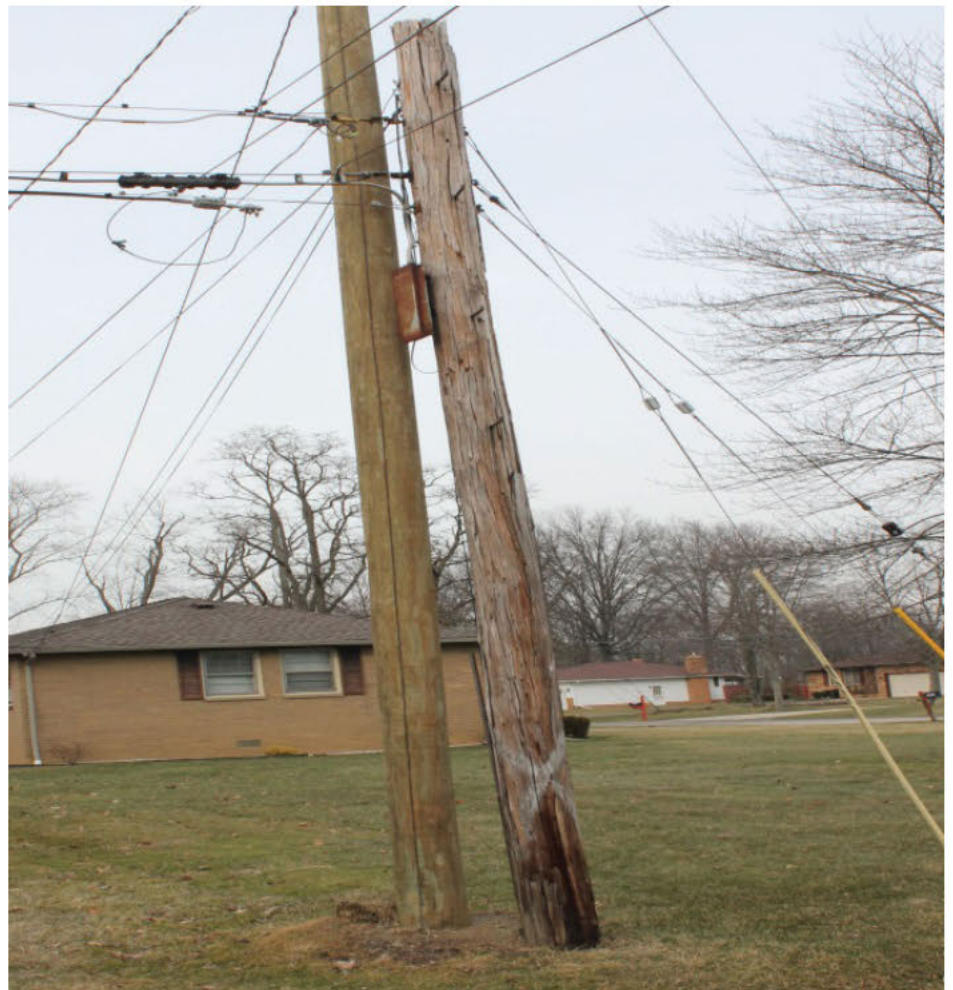
18. This photo from Wolf Lane, Strongsville, OH shows a double-pole. Only AT&T equipment is attached to the old pole (right, with a white spray-painted X). AT&T has not moved its facilities to the new utility pole. As a result, AT&T's equipment remains connected to an old, deteriorating pole, causing potential service and safety concerns. In addition, AT&T's terminal is severely rusted.

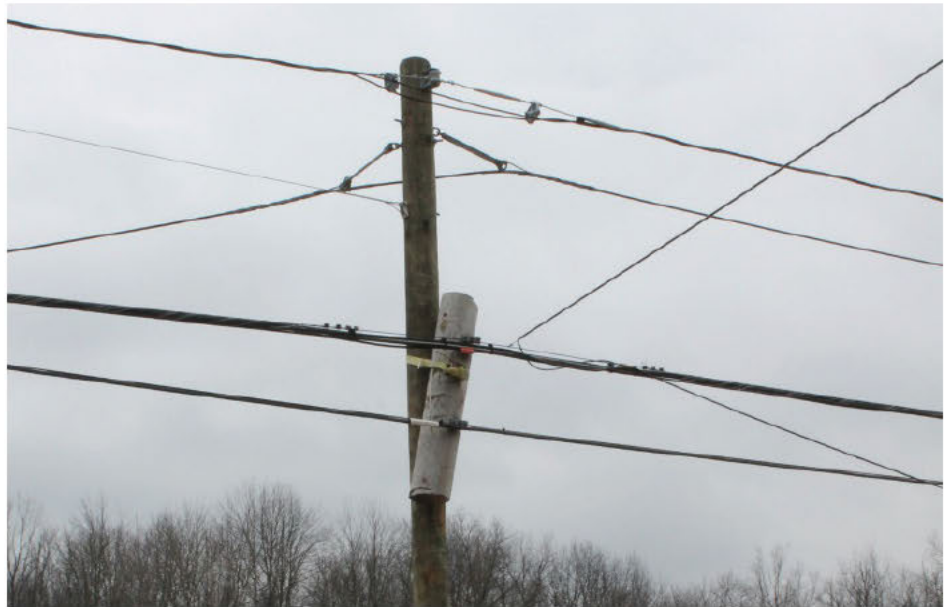
19. This photo from South Thomas Road, Tallmadge Road, OH, shows a hanging pole, or a double-pole that has been cut before AT&T moved its facilities to the new pole. The old utility pole was cut with AT&T's terminal still attached to it. Left dangling, the old pole strains the cables and endangers the public. It is a service, worker, and public safety concern.

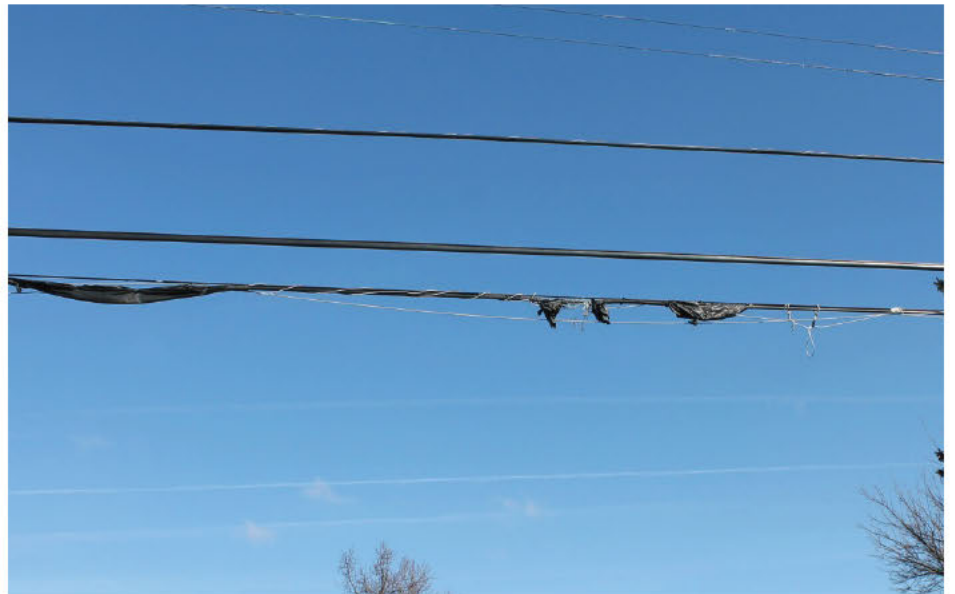
20. This photo from West 2nd Street, Girard, OH, shows a severely damaged cable. Some remnants of a black plastic cover remain. The cable is damaged, leaving wires exposed to weather and animals. Damaged wires cause service outages.

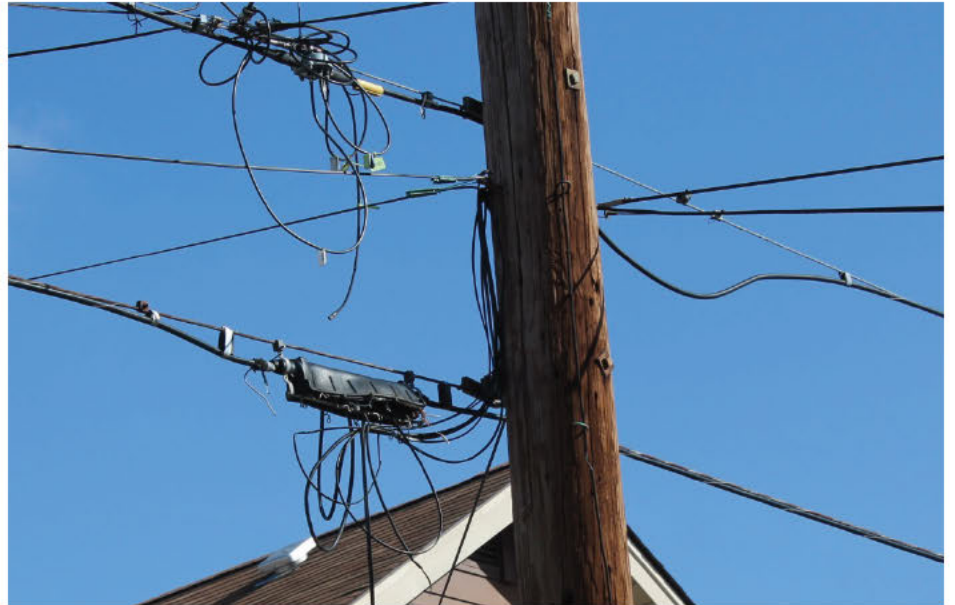
21. This photo from East 2nd Street, Girard, OH, shows a severely damaged splice terminal. The terminal's protective case is hanging open, leaving wires exposed to weather and animals. Damaged wires cause service outages.

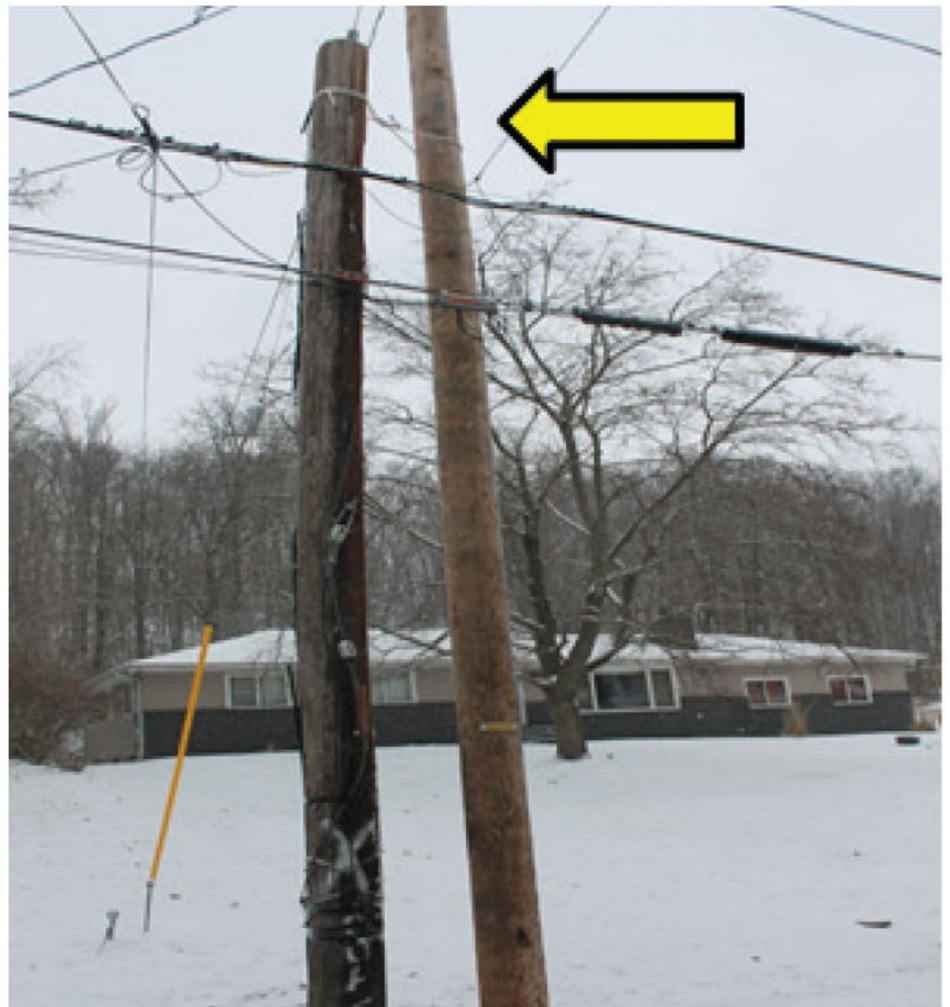
22. This photo from Green Haven Parkway, Brecksville, OH, shows a double-pole. The old pole (left, with a white spray-painted X) with only AT&T equipment attached to it is tied to the new pole with rope to prevent it from falling (yellow arrow). AT&T has not moved its facilities to the new utility pole. As a result, AT&T's equipment remains connected to old, deteriorating poles, causing potential service and safety concerns.

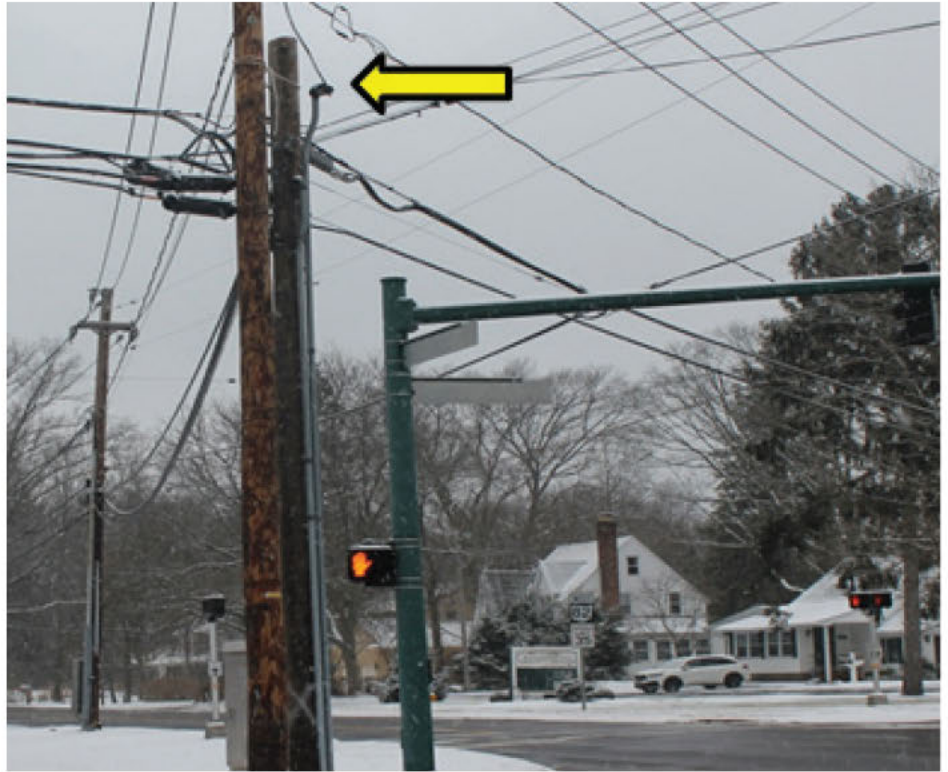
23. This photo from Route 82, Brecksville, OH, shows a double-pole. The old pole (right, with a white spray-painted X) with only AT&T equipment attached to it is tied to the new pole with rope to prevent it from falling (yellow arrow). AT&T has not moved its facilities to the new utility pole. As a result, AT&T's equipment remains connected to old, deteriorating poles, causing potential service and safety concerns.

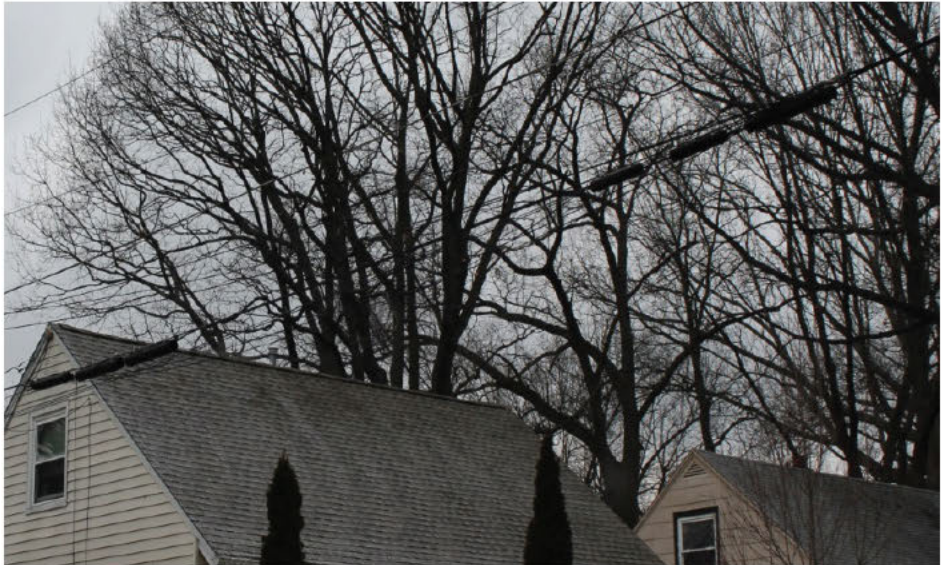
24. This photo from Hillside Street, Cuyahoga Falls, OH, shows a badly damaged cable. Instead of replacing the cable, AT&T installed multiple splice boxes on the cable. Each splice box covers a portion of damaged or defective cable. AT&T also used drop wires to bypass sections of bad cable. Each of the numerous thin wires would have been installed in response to a separate customer complaint.

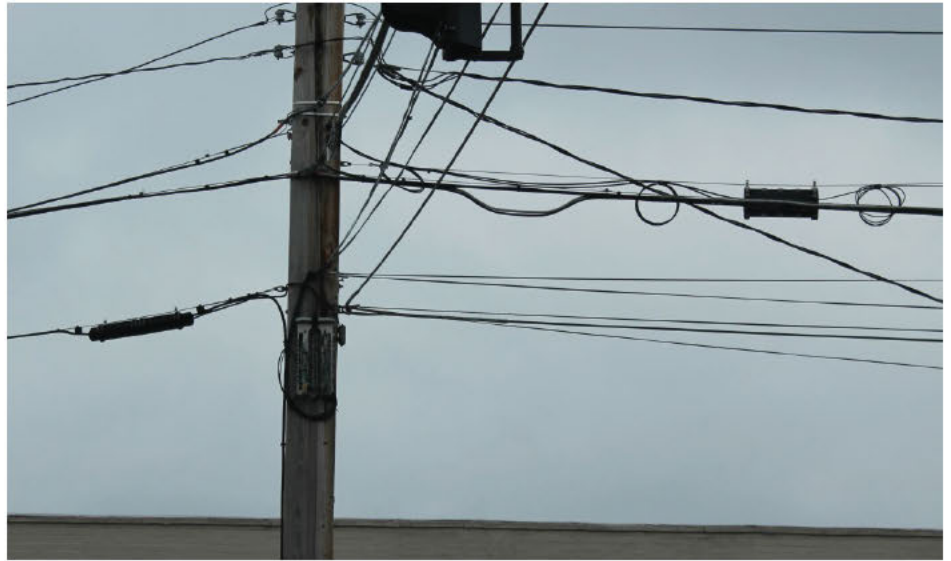
25. This photo from Hudson Drive, Cuyahoga Falls, OH, shows a severely damaged terminal. The terminal's protective case is missing, leaving wires exposed to weather and animals. Damaged wires cause service outages.
