AT&T:
Abandoning Rural & Other
Communities in Wisconsin

AT&T Copper Plant Photos – Wisconsin

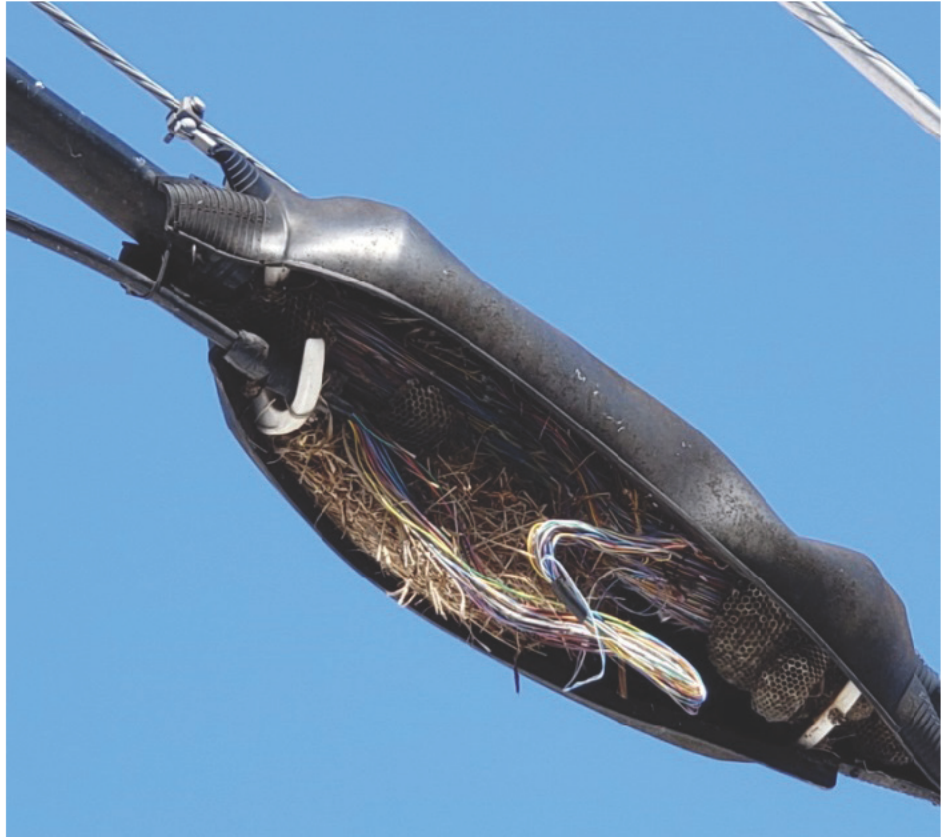
1. This photo from West 12th Street, Fond Du Lac, WI, shows a severely damaged splice case. The splice's protective case is hanging open, leaving wires exposed to weather and animals. Damaged wires cause service outages. In addition, birds are nesting inside the terminal, leading to further wire damage.

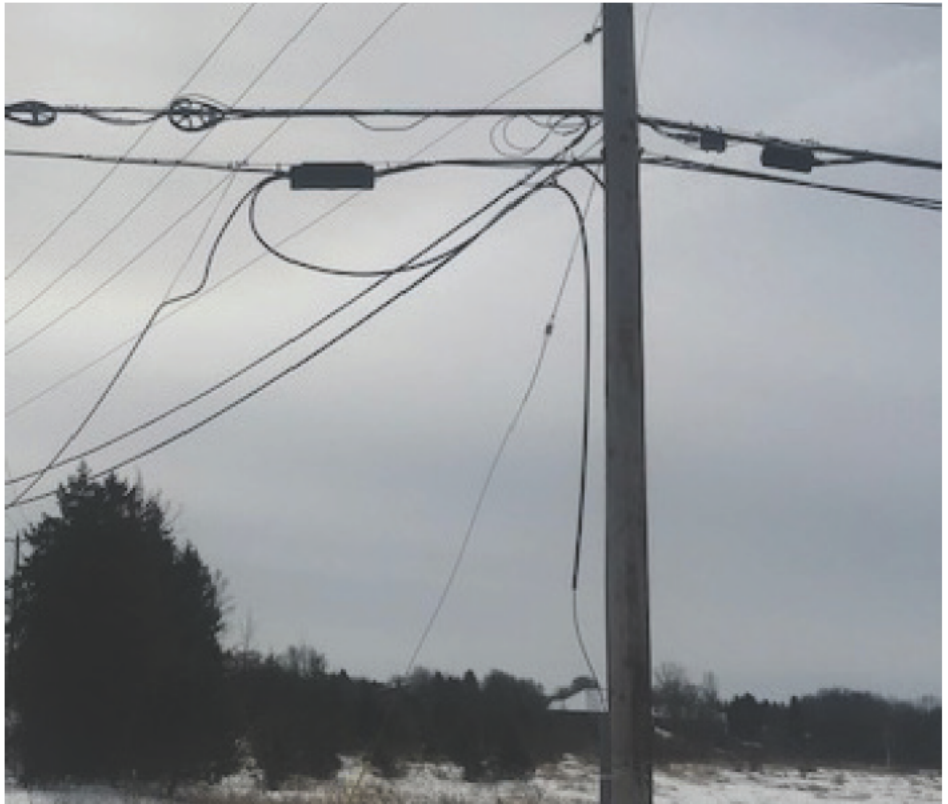
2. This photo from South Division Street, Port Washington, WI, shows unsecured cable. The cable should be secured to the utility pole. The wind blows the unsecured service cable, damaging the copper inside the wire and causing service issues. In addition, this cable is within reach of passersby, causing a public safety hazard.

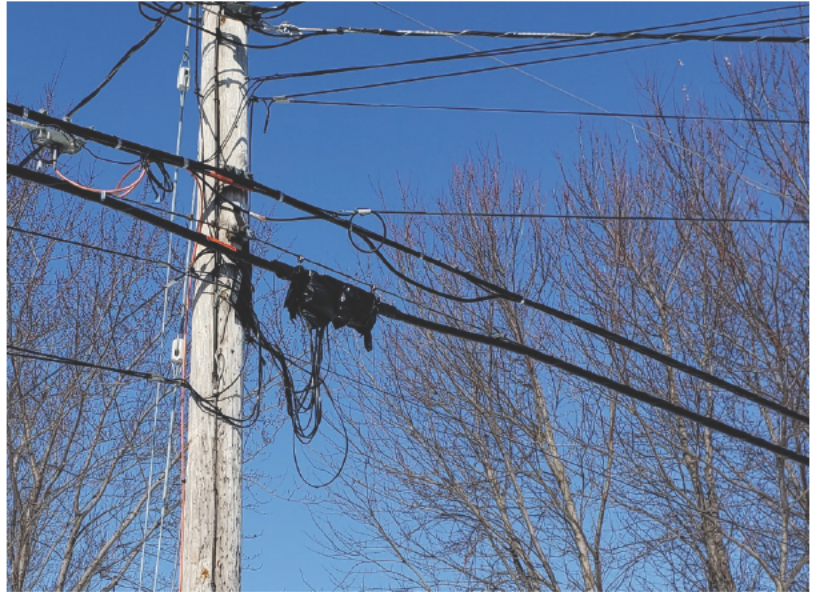
3. This photo from County Road, Neenah, WI, shows a severely damaged splice terminal. The terminal's protective case is hanging open, leaving wires exposed to weather and animals. Damaged wires cause service outages.

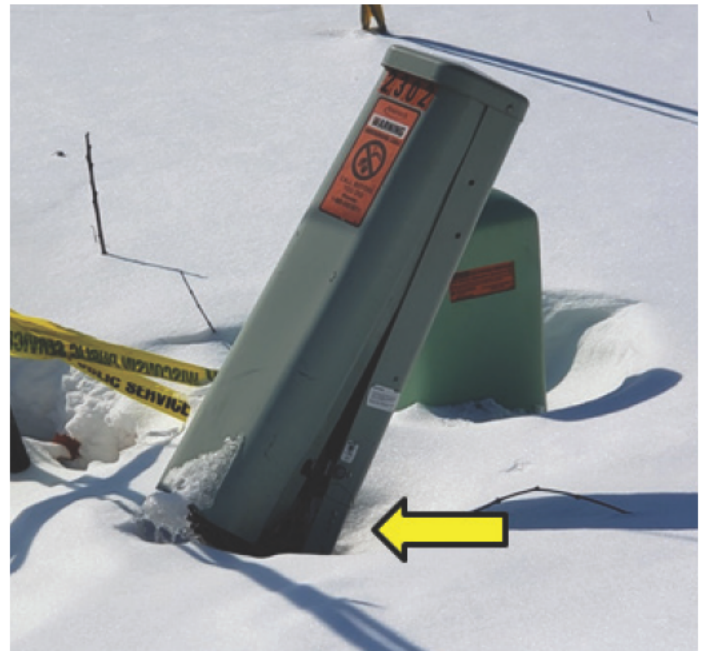
4. This photo from Old Plank Road, DePeere, WI, shows a damaged pedestal. Its protective cover is damaged (yellow arrow), leaving wires exposed to damage from weather and animals. Damaged wires cause service outages. In addition, the exposed wires are a public safety hazard.

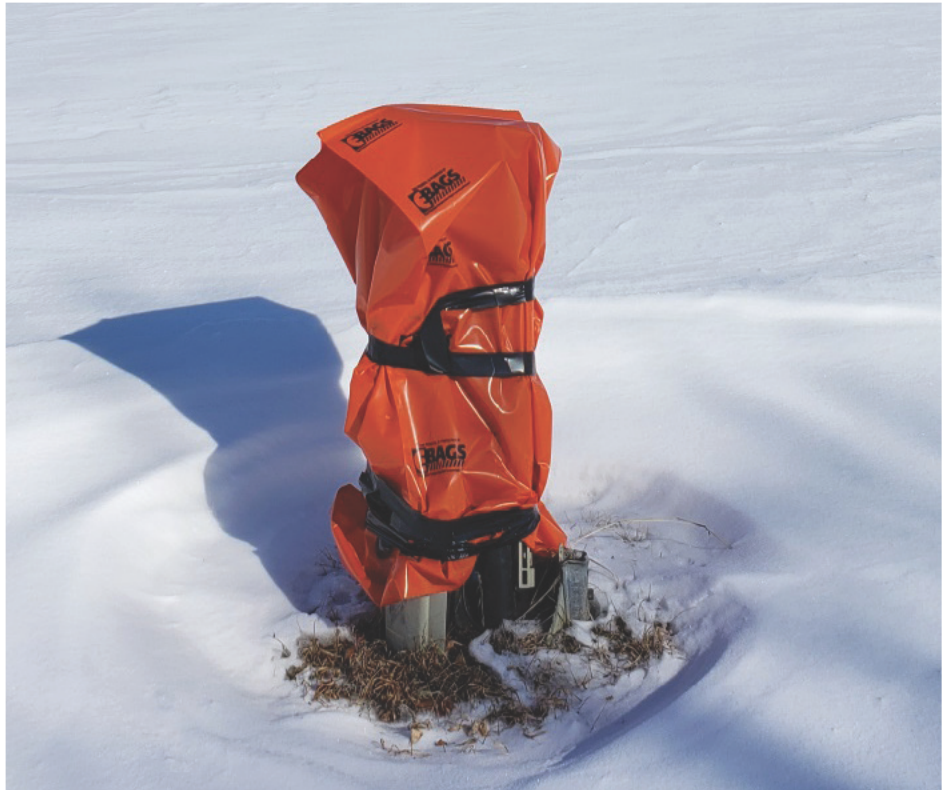
5. This photo from North Westhill Boulevard, Appleton, WI, shows a damaged pedestal. Its protective cover is missing, partially replaced with an orange plastic covering. This plastic covering will fall off or deteriorate over time, leaving wires exposed to weather and animals. Damaged wires cause service outages. In addition, the exposed wires are a public safety hazard.

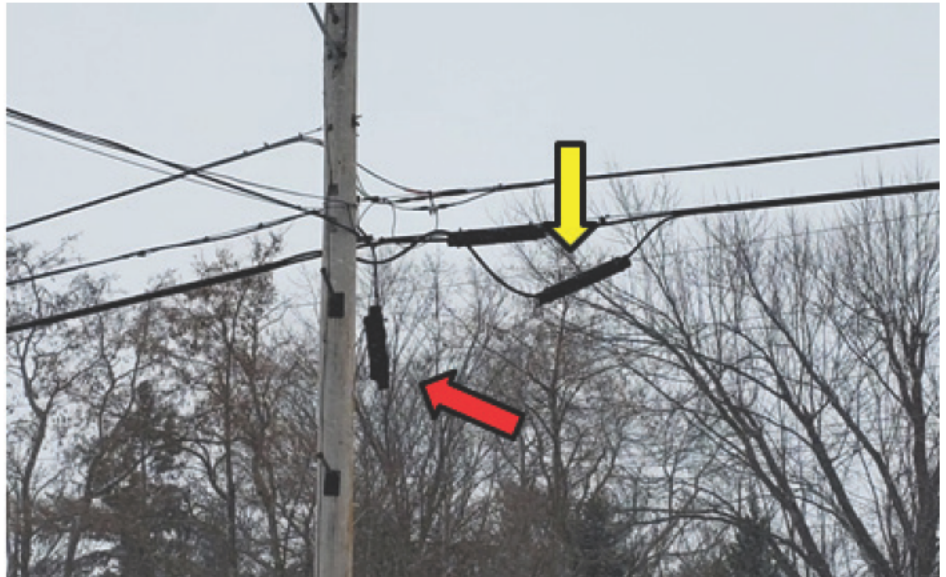
6. This photo from West Main Street, Hortonville, WI, shows a damaged splice terminal and unsecured cable. Splice terminals should be secured to cable, not left hanging (red arrow). And cable should be secured to the utility pole (yellow arrow). The wind blows the unsecured service cable, damaging the copper inside the wire and causing service issues.

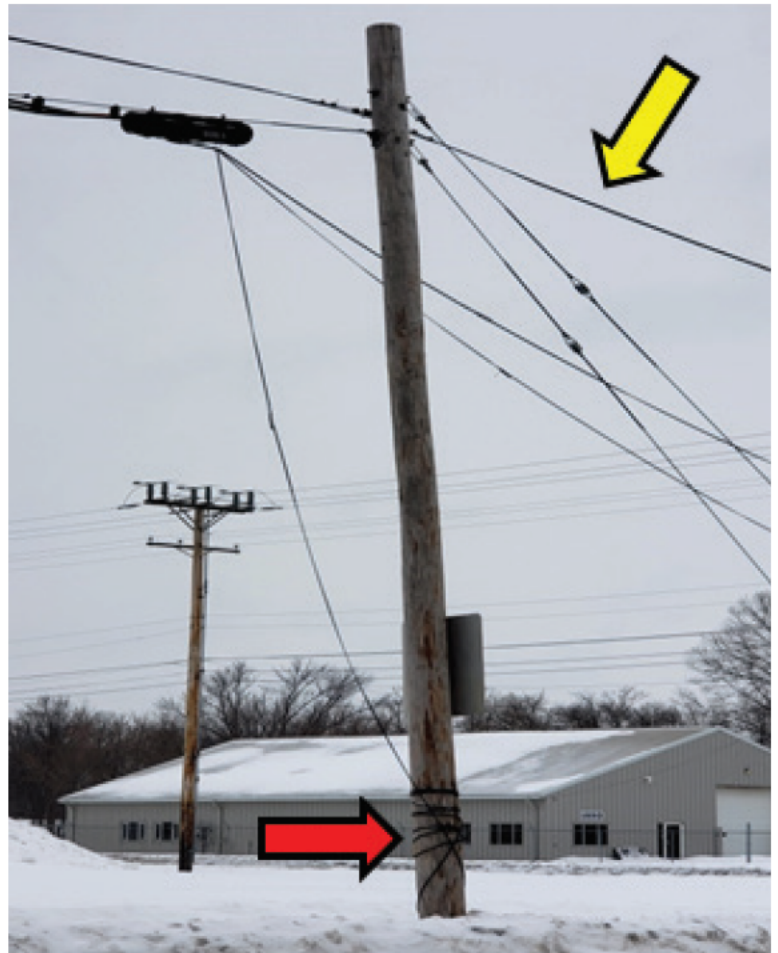
7. This photo from Spencer Street, Appleton, WI, shows unsecured cables. The cables are meant to be secured to the utility pole, not merely taped to the pole with electrical tape (yellow arrow), or secured to a lash (red arrow). The wind blows the unsecured service cable, damaging the copper inside the wire and causing service issues. In addition, this cable is within reach of passersby, causing a public safety hazard.

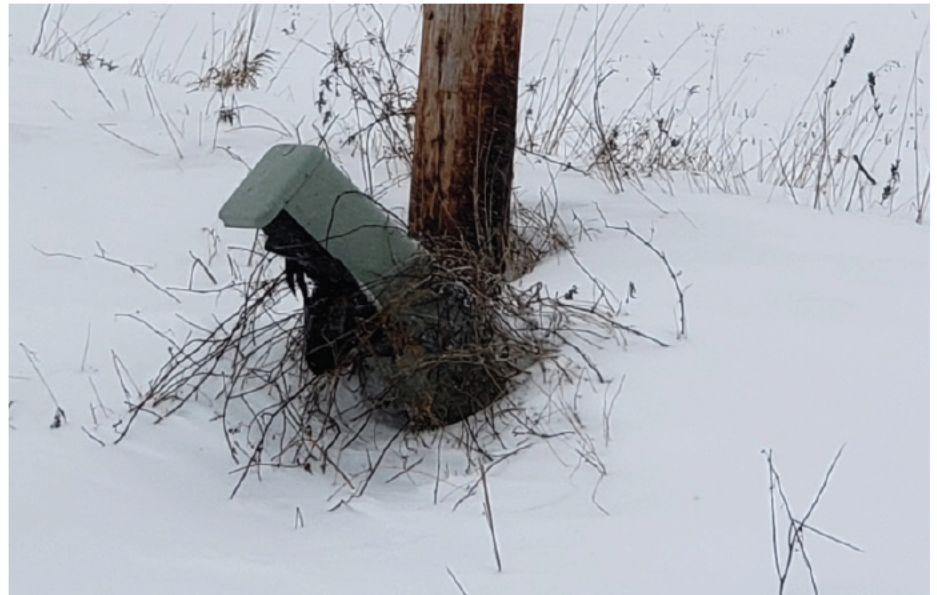
8. This photo from Mayflower Road, Greenville, WI, shows a damaged pedestal. Its protective cover is missing, leaving wires exposed to weather and animals. Damaged wires cause service outages. In addition, the exposed wires are a public safety hazard.

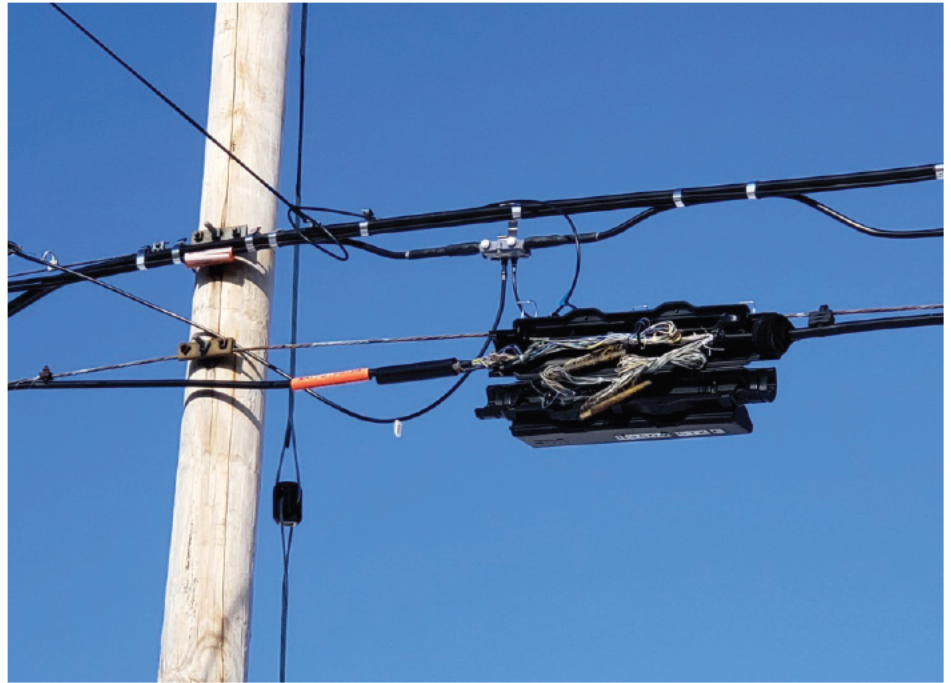
9. This photo from County Road, East Freedom, WI, shows a severely damaged splice case. The splice's protective case is hanging open, leaving wires exposed to weather and animals. Damaged wires cause service outages.

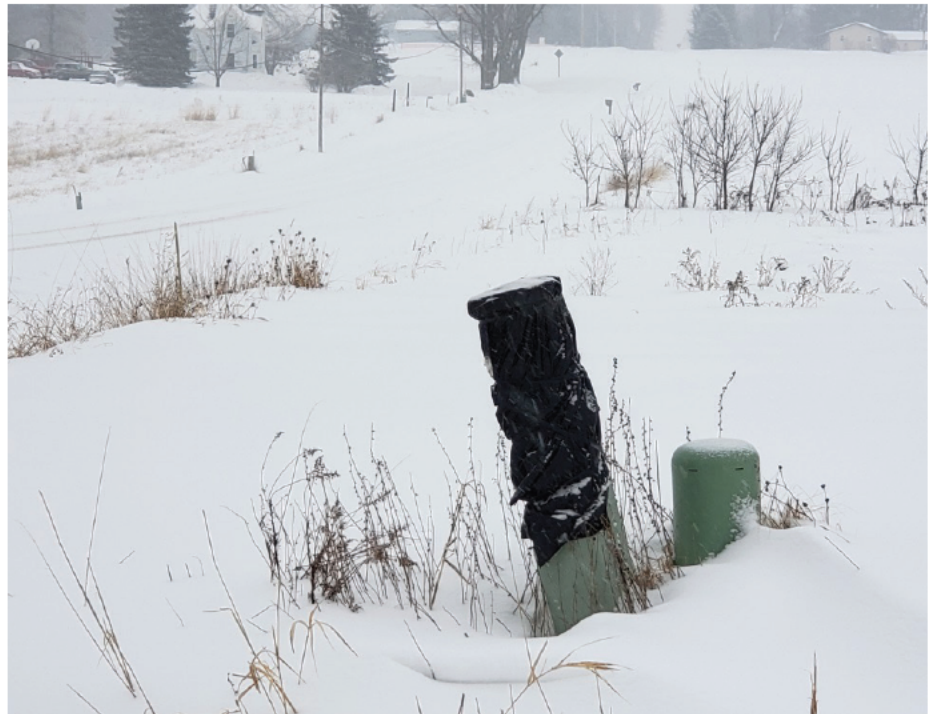
10. This photo from Rexford Road, Shiocton, WI, shows a damaged pedestal. Its protective cover is missing, replaced with a black plastic covering. This plastic covering will fall off or deteriorate over time, leaving wires exposed to weather and animals. Damaged wires cause service outages. In addition, the exposed wires are a public safety hazard.

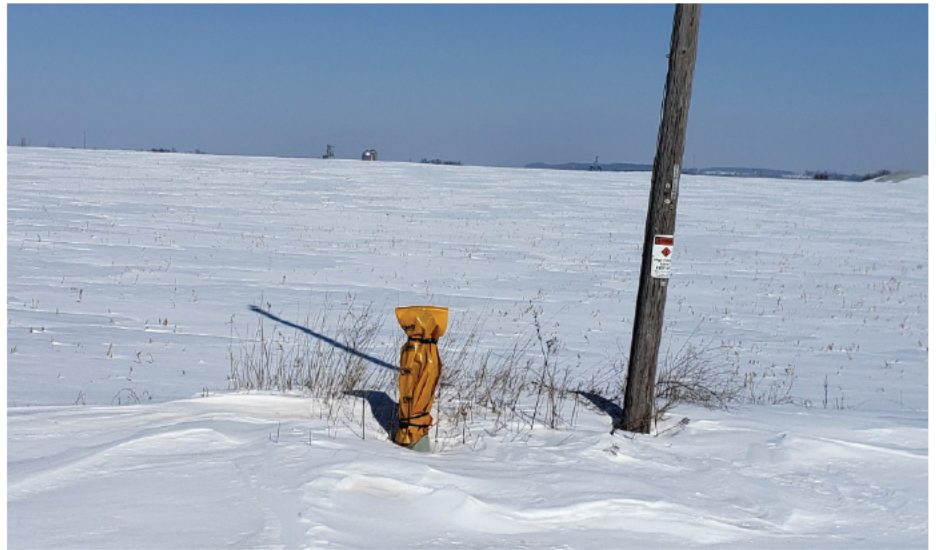
11. This photo from Clancy Road, Greenleaf, WI, shows a damaged pedestal. Its protective cover is missing, replaced with an orange plastic covering. This plastic covering will fall off or deteriorate over time, leaving wires exposed to weather and animals. Damaged wires cause service outages. In addition, the exposed wires are a public safety hazard.

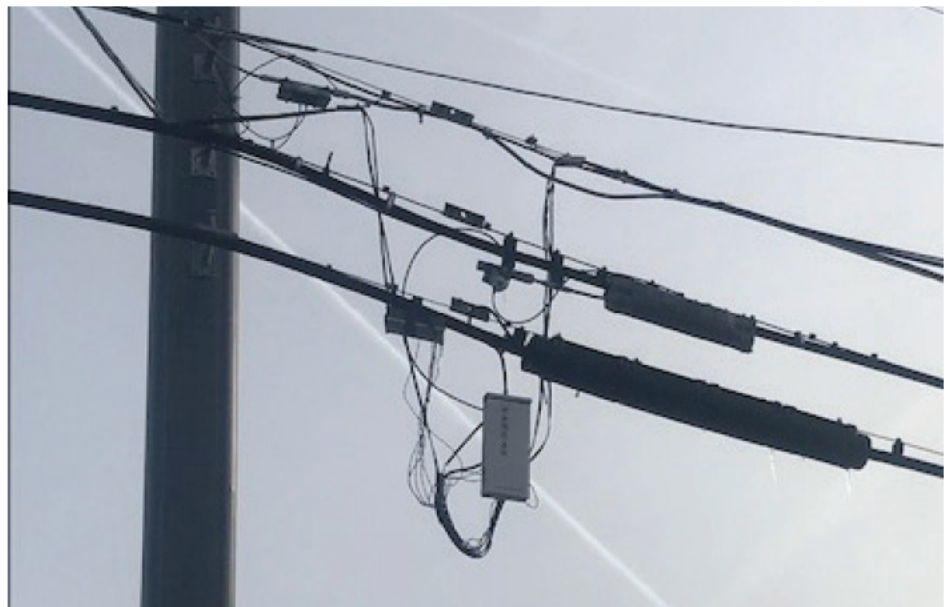
12. This photo from Clancy Road, Greenleaf, WI, shows an unsecured hanging terminal. The terminal should be secured to the utility pole. The terminal can fill with water, deteriorating wires and leading to service issues. In addition, a hanging terminal presents a public safety hazard.

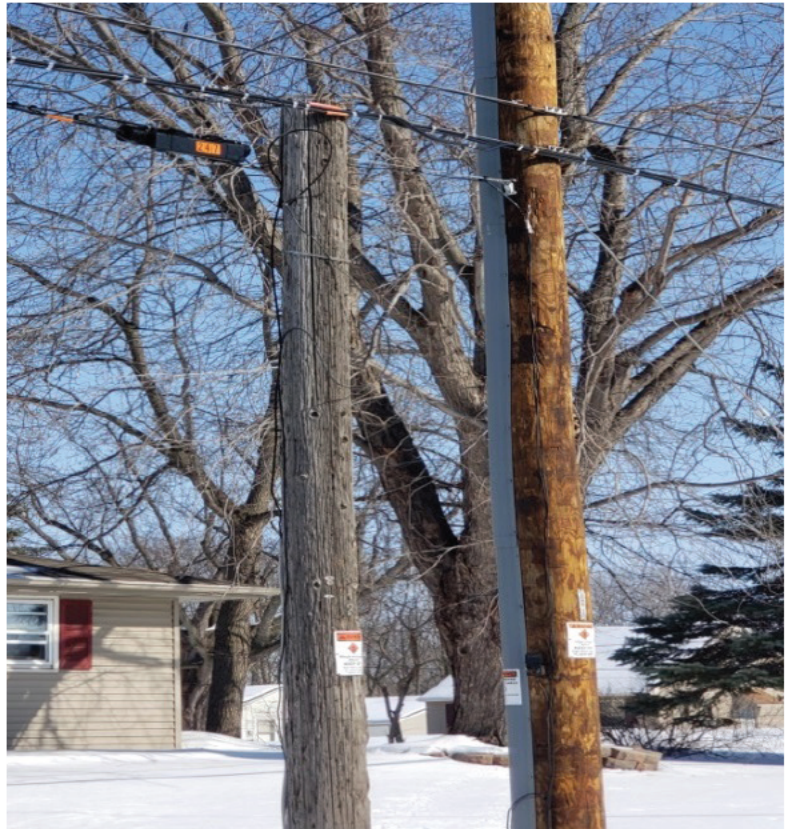
13. This photo from High Street, Wrightstown, WI, shows a double-pole. The old pole (left) has only AT&T equipment attached to it. AT&T has not moved its facilities to the new utility pole. As a result, AT&T's equipment remains connected to an old, deteriorating pole, potentially leading to service and safety concerns.

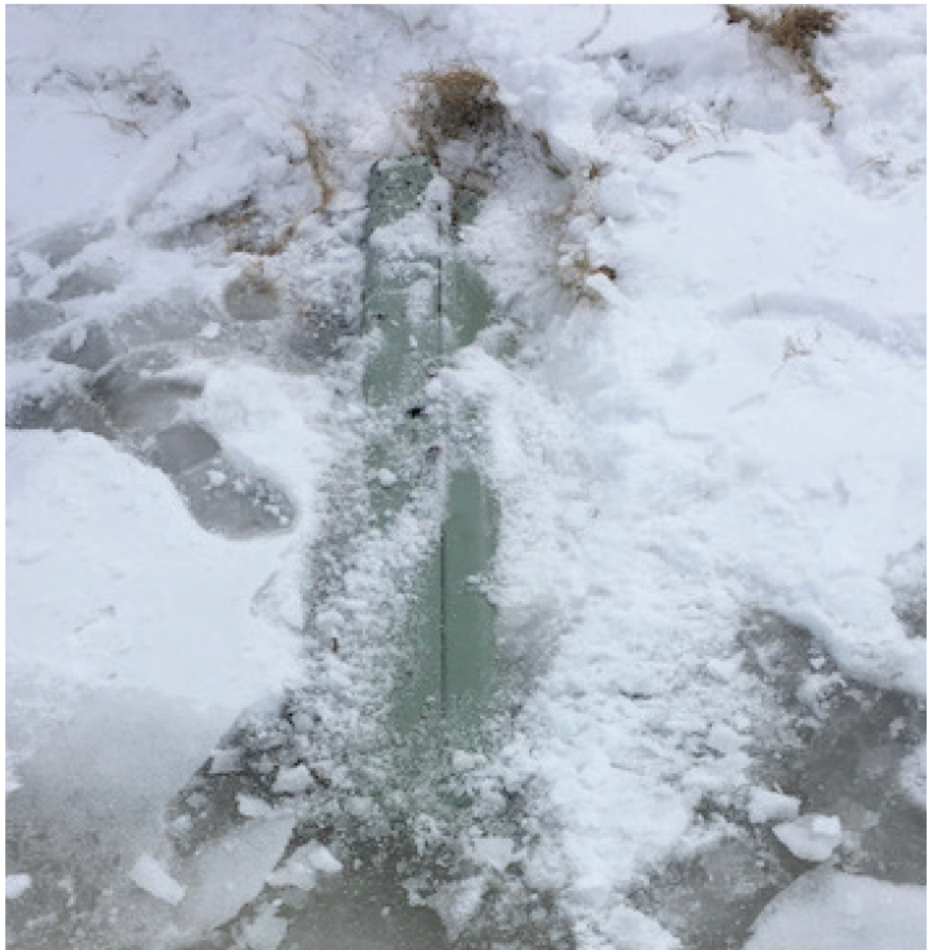
14. This photo from Helsan Drive, Richfield, WI, shows a damaged pedestal on its side. Ice and snow have covered the pedestal. Water will enter the pedestal and damage internal wires. Damaged wires cause service outages.

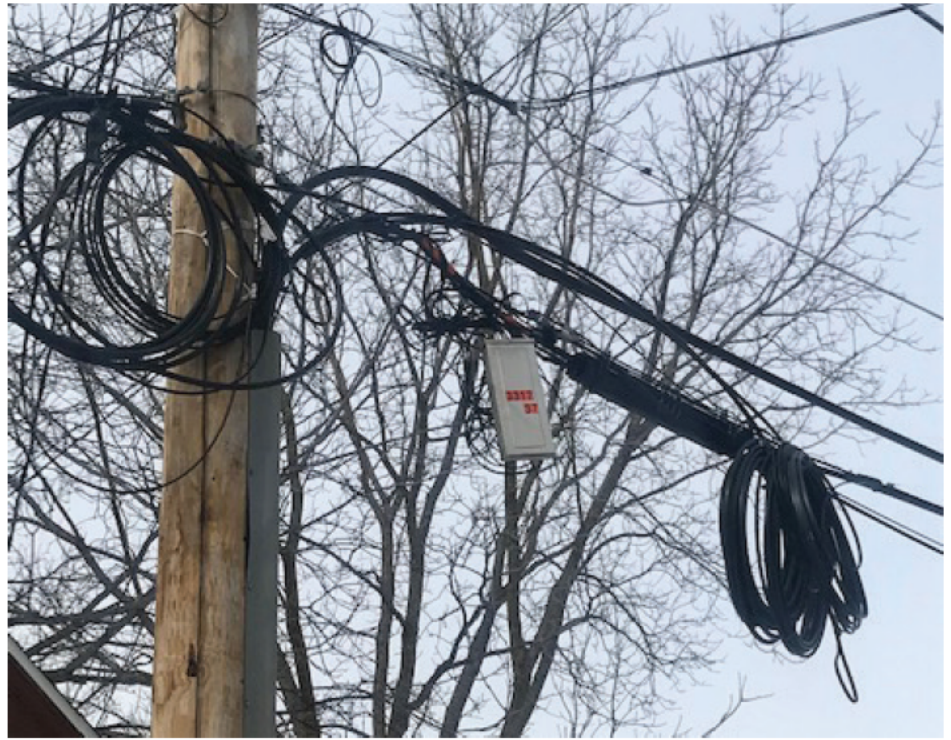
15. This photo from North 37th Street, Milwaukee, WI, shows an unsecured terminal hanging from service wires. The terminal should be secured to the pole. The terminal can fill with water, deteriorating wires and leading to service issues. In addition, a hanging terminal presents a public safety hazard.

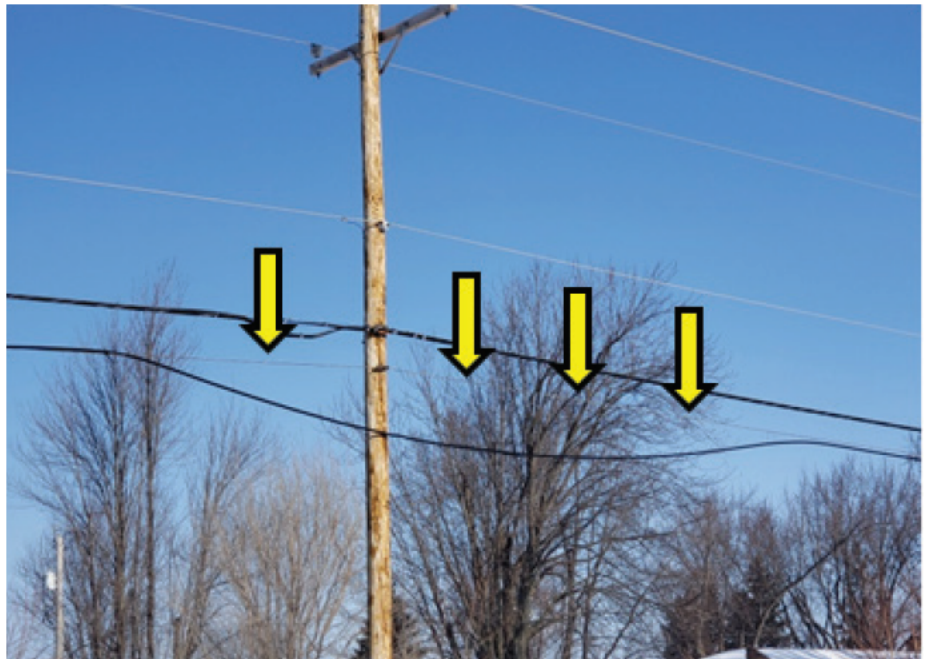
16. This photo from County Road, East Freedom, WI, shows an unsecured cable. The cable should be secured to the lash (yellow arrows) and the utility pole. The wind blows the unsecured cable, damaging the copper inside the wire, causing service issues, and straining the properly lashed cable.

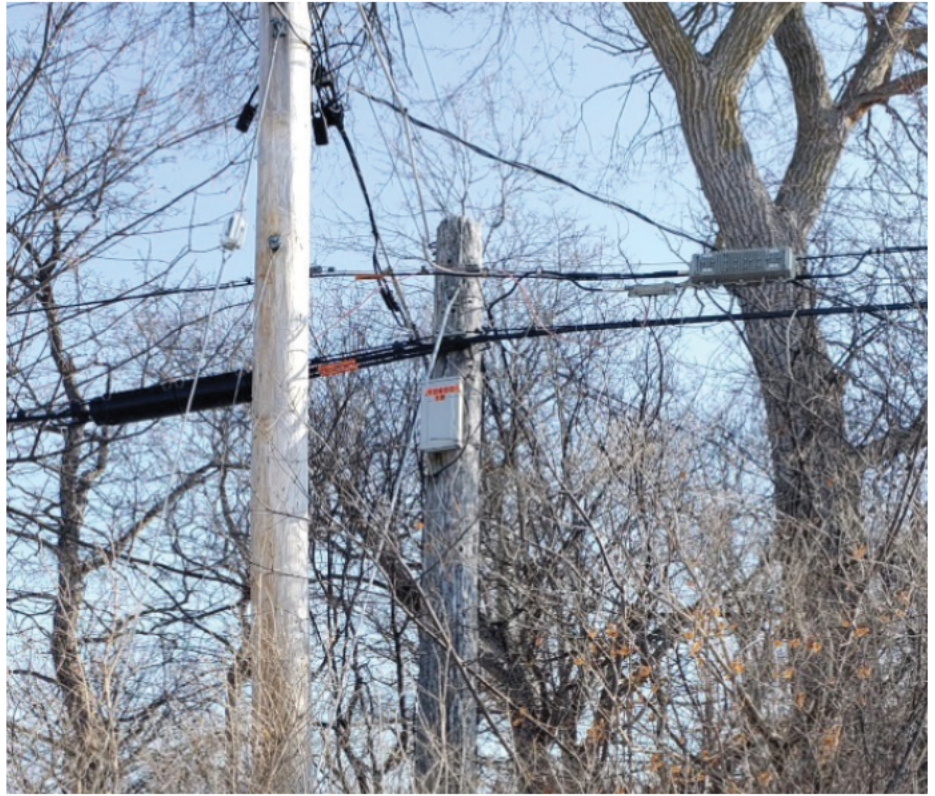
17. This photo from Green Bay Road, Neenah, WI, shows a double-pole. The old pole (right) has only AT&T equipment attached to it. AT&T has not moved its facilities to the new utility pole. As a result, AT&T's equipment remains connected to an old, deteriorating pole, causing potential service and safety concerns.

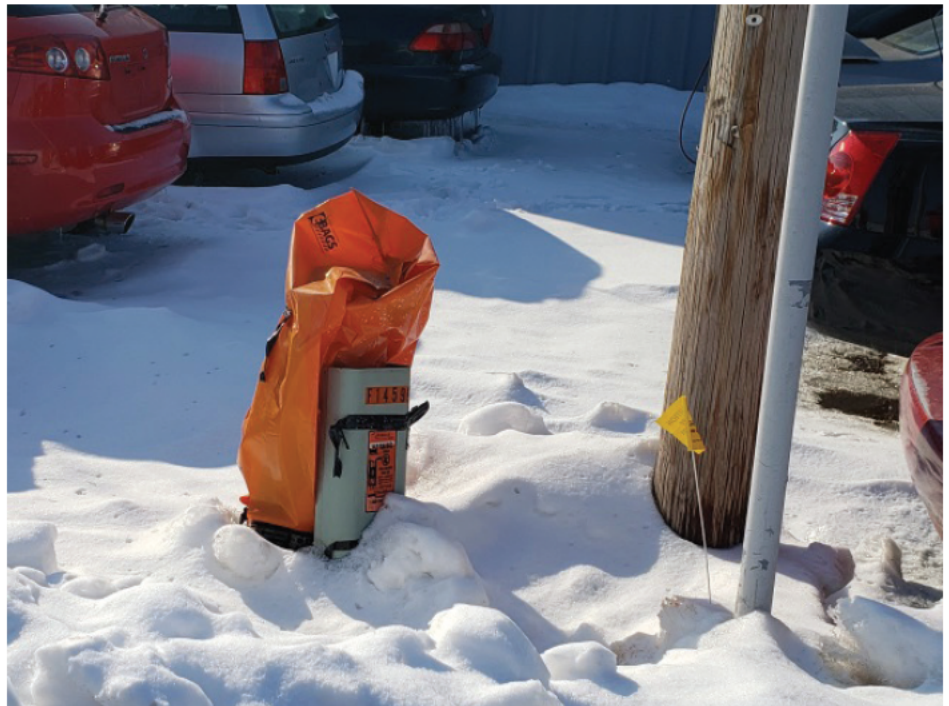
18. This photo from Plainview Drive, Oshkosh, WI, shows a damaged pedestal. Its protective cover is missing, replaced with an orange plastic covering. This plastic covering will fall off or deteriorate over time, leaving wires exposed to weather and animals. Damaged wires cause service outages. In addition, the exposed wires are a public safety hazard.

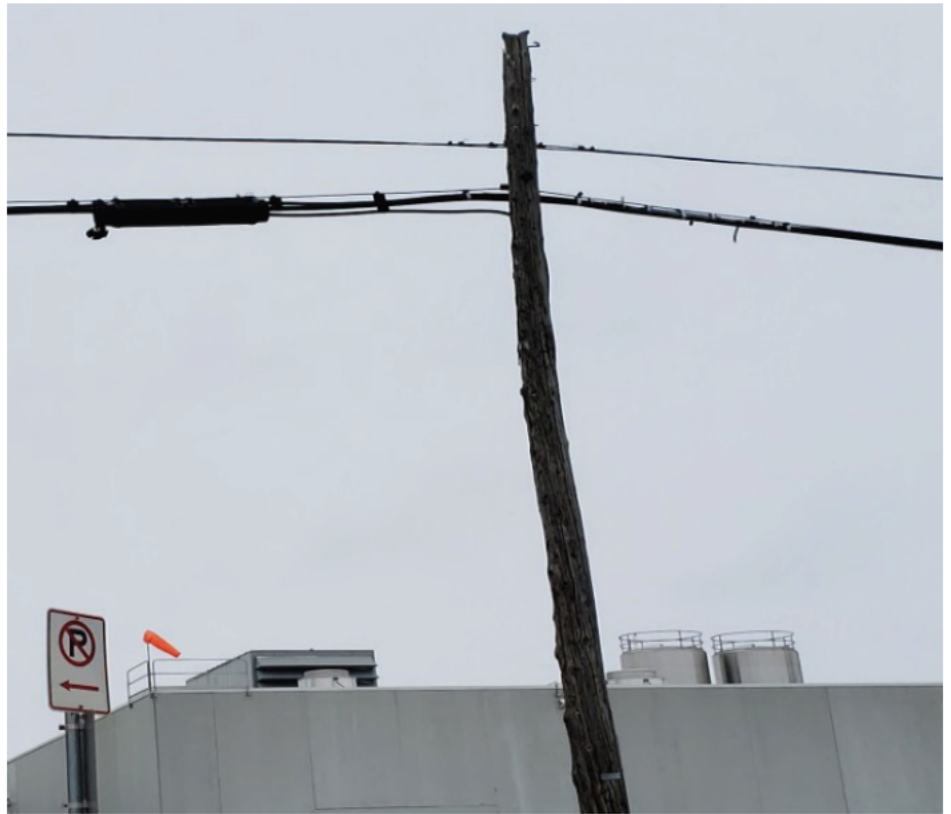
19. This photo from West Spencer Street, Appleton, WI, shows a rotting pole. AT&T's equipment is the only equipment that remains. AT&T has not moved its facilities to the new utility pole. As a result, AT&T's equipment remains connected to an old, deteriorating pole, causing potential service and safety concerns.

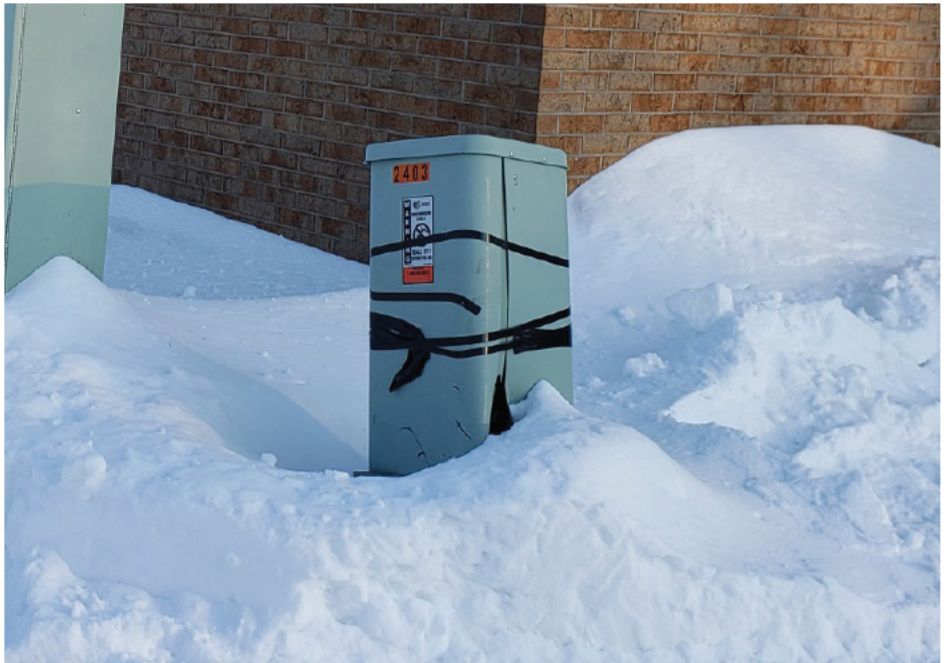
20. This photo from County Road, Neenah, WI, shows a damaged pedestal. Its protective cover is damaged, taped shut with electrical tape. Electrical tape is not designed to do this. It will deteriorate over time, leaving wires exposed to damage from weather and animals. Damaged wires cause service outages. In addition, the exposed wires are a public safety hazard.

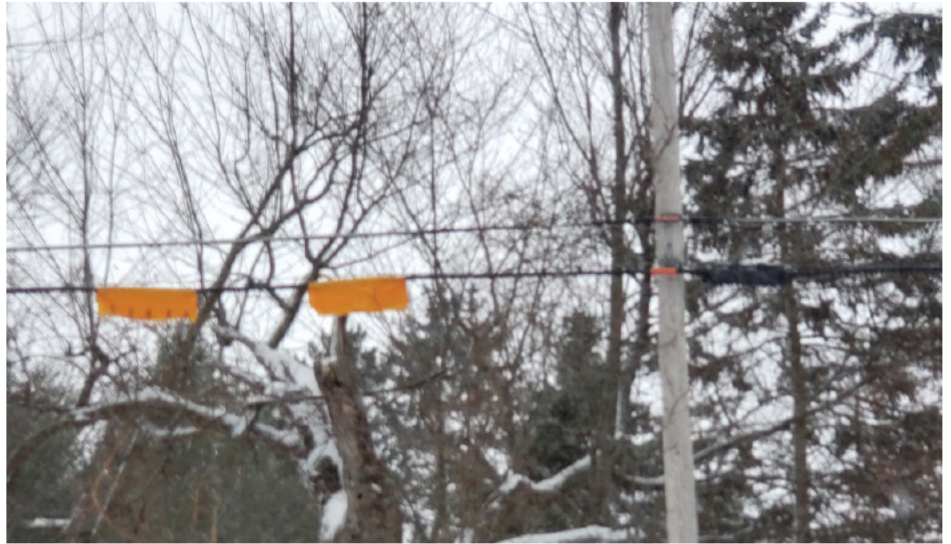
21. This photo from State Road, Hortonville, WI, shows two damaged splices wrapped in orange plastic coverings. Once the wrap deteriorates, wires are exposed to weather and animals. Damaged wires cause service outages.

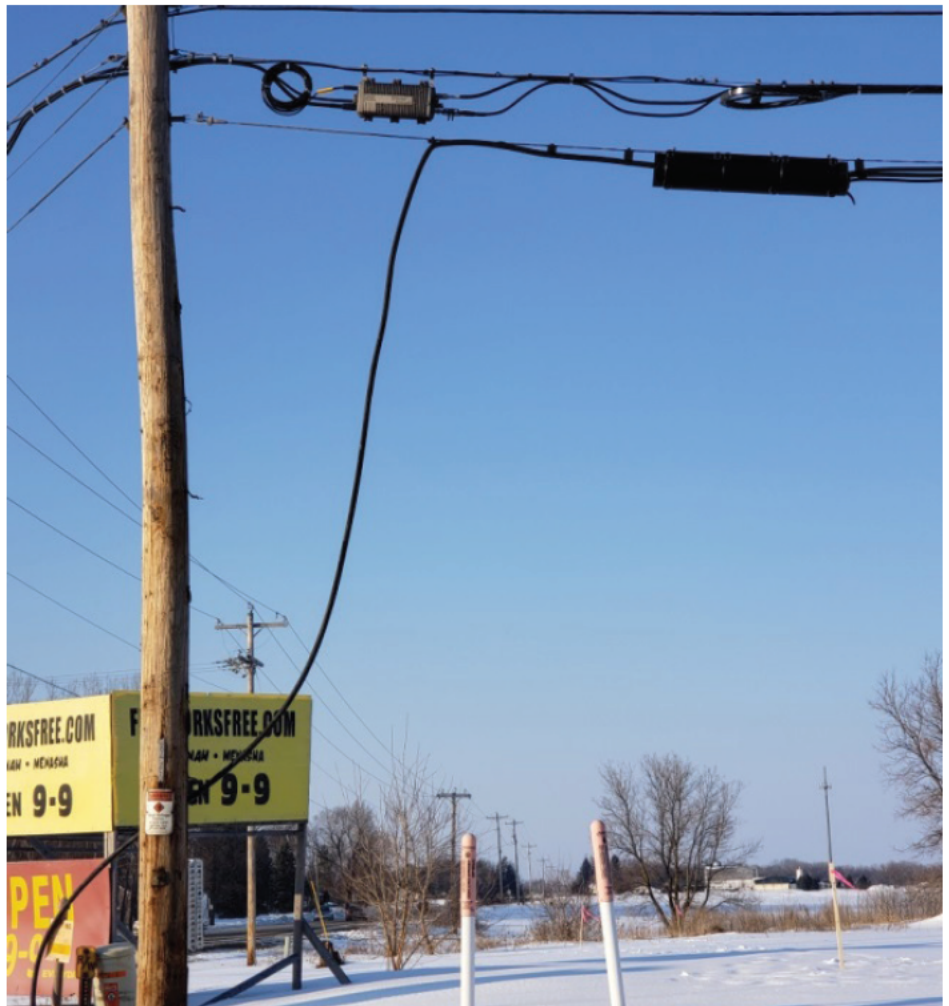
22. This photo from Breezewood Lane, Neenah, WI, shows unsecured cable. The cable should be secured to the utility pole. The wind blows the unsecured service cable, damaging the copper inside the wire and causing service issues. In addition, this cable is within reach of passersby, causing a public safety hazard.

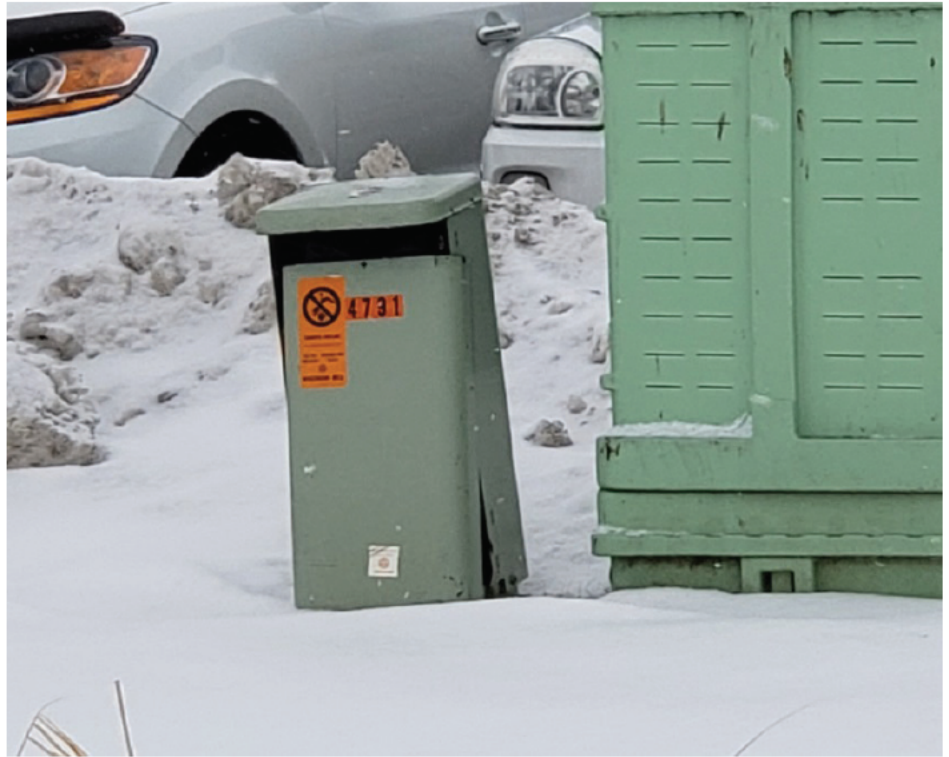
23. This photo from West Wisconsin Avenue, Appleton, WI, shows a damaged pedestal. Its protective cover is unsecured. Wires are exposed to damage from weather and animals. Damaged wires cause service outages. In addition, the exposed wires are a public safety hazard.

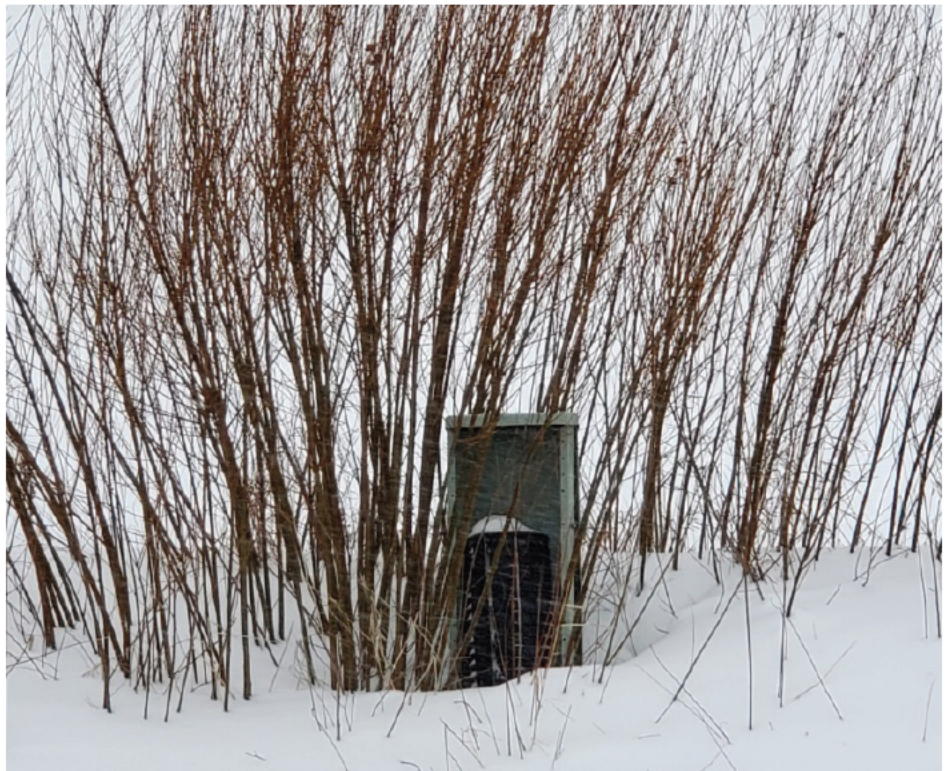
24. This photo from Greenville Drive, Greenville, WI, shows a damaged pedestal. Its protective cover is missing. Wires are exposed to damage from weather and animals. Damaged wires cause service outages. In addition, the exposed wires are a public safety hazard.

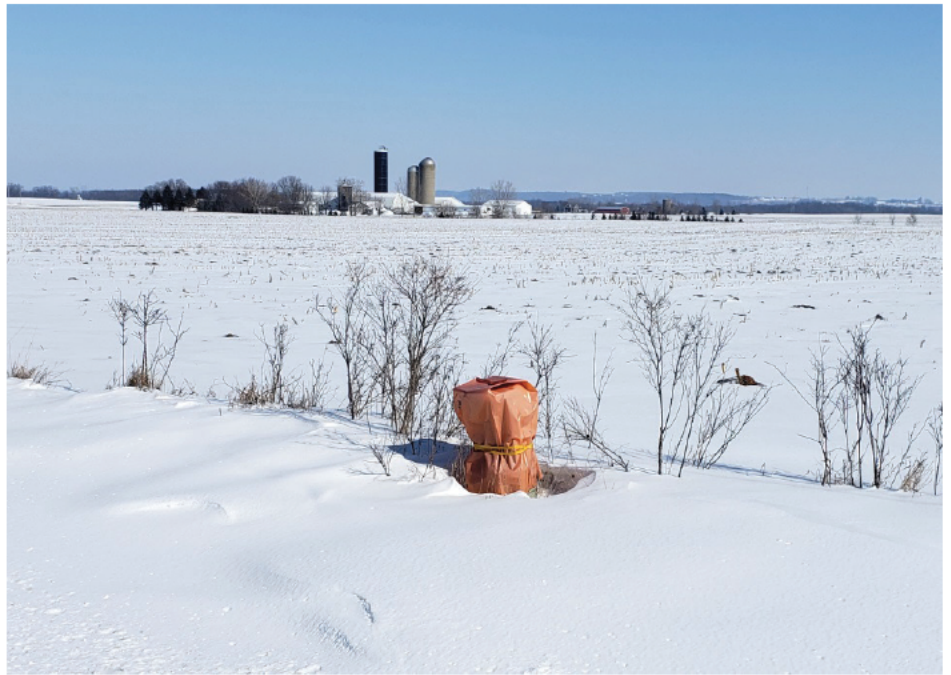
25. This photo from Shanty Road, Wrightstown, WI, shows a damaged pedestal. Its protective cover is missing, partially replaced with an orange plastic covering. This plastic covering will fall off or deteriorate over time, leaving wires exposed to weather and animals. Damaged wires cause service outages. In addition, the exposed wires are a public safety hazard.

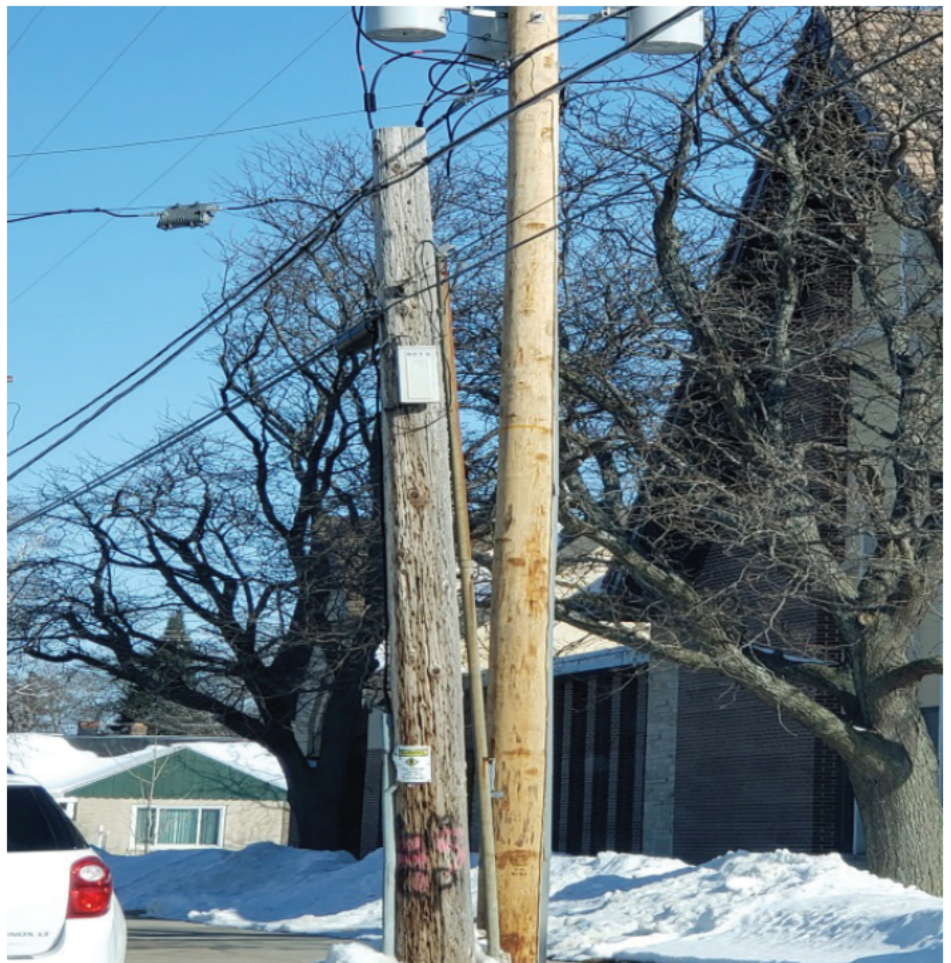
26. This photo from East Glendale Avenue, Appleton, WI, shows a double-pole. The old pole (left) has only AT&T equipment attached to it. AT&T has not moved its facilities to the new utility pole. As a result, AT&T's equipment remains connected to an old, deteriorating pole, causing potential service and safety concerns to the nearby road.
